**Government of India
Geological Survey of India**

**A Preliminary Report on
Investigation of Effects of the
Sumatra - Andaman Earthquake
of 26 December 2004
In Andaman and Nicobar Islands**

January 2005

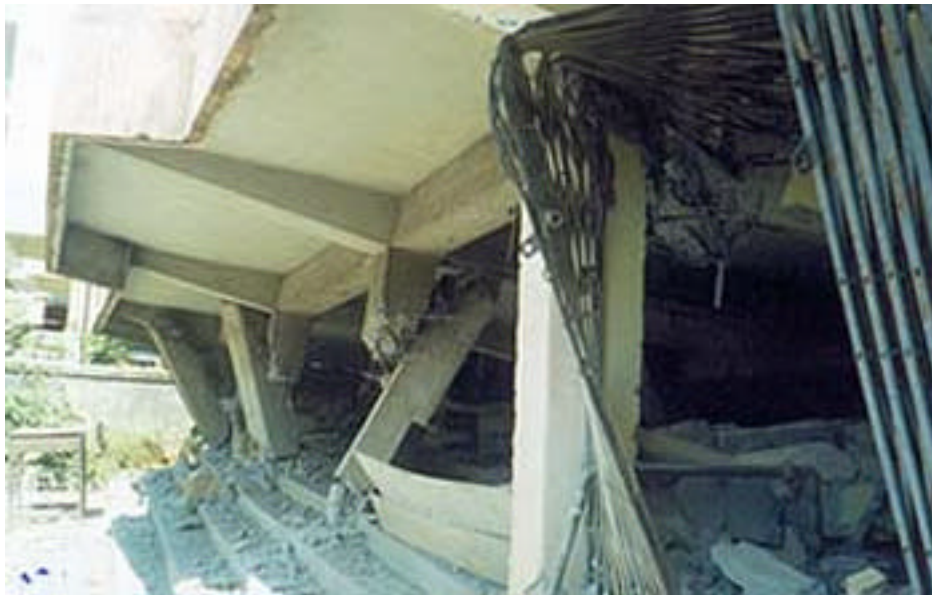
Different grades of damage to buildings have been recorded from different parts of South Andaman. In Port Blair area, places like, Marine Park, Aberdeen jetty, Chatam, Nayagaon, Bamboo Flat, etc. were visited. Buildings like the Secretariat, Haddo Circuit House, Blair Hotel, which are Type C structures suffered damage of grades 1 and 2. Most buildings of B/C type in and around Port Blair suffered similar damage. In a single case at Nayagaon a newly constructed 3-story building over stilt with RCC columns and beams suffered grade 5 damage. The entire soft-story ground floor caved in due to failure of load bearing base column (Photo 2 & 3). The upper two floors though tilted, were much less damaged. In the Bamboo Flat area many of the buildings showed grade 2 cracks. In a newly constructed house belonging to C. Mahammad Arif, which at the time of the earthquake was not even occupied, much higher damage was seen in comparison with rest of the area. This two-story structure with RCC columns, beams and RCC roof caved in such a manner that the ground floor got completely crushed and the first floor came to the ground floor level (Photo 4). This was also a stilted structure where the base columns were not tied with shear walls. It appears that under condition of prolonged lateral loading the base columns supporting a heavy load sheared off resulting in grade 5 damage.

Photo 2: Shearing of load bearing base columns leading to the caving in of G+2 storied RCC structure, Naya Gaon, Port Blair

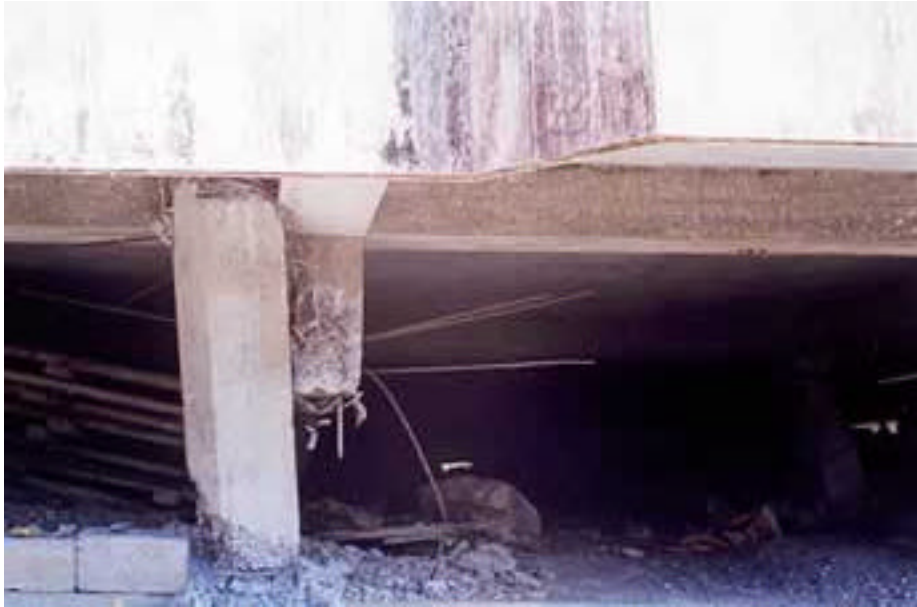
Photo 3: Sheared base column and caved in stilt, Naya Gaon,Port Blair

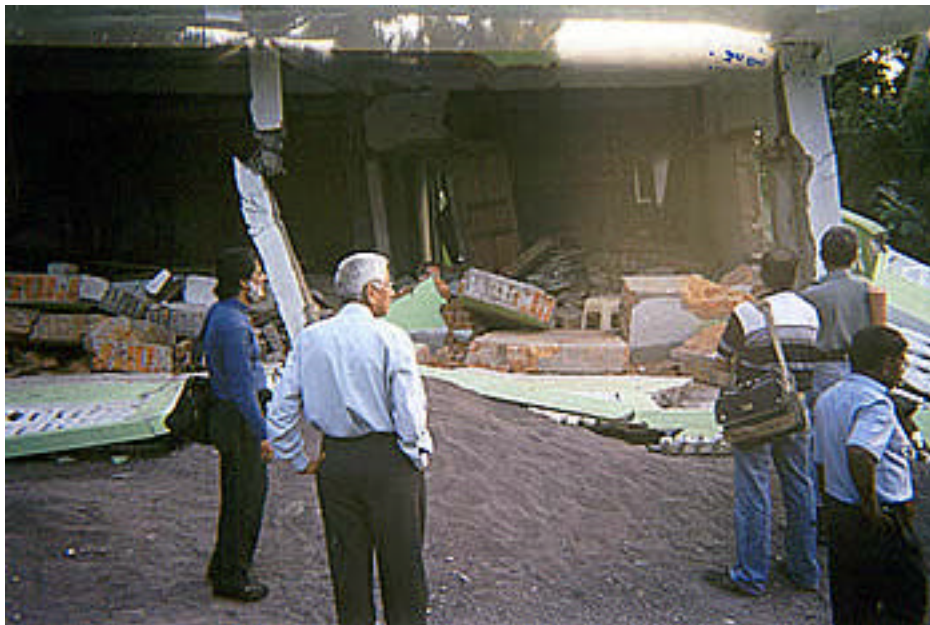
Photo 4: Complete crushing of ground floor due to failure of basecolumn and first floor collapsing to the ground level of a newly constructed building in Bamboo Flat area

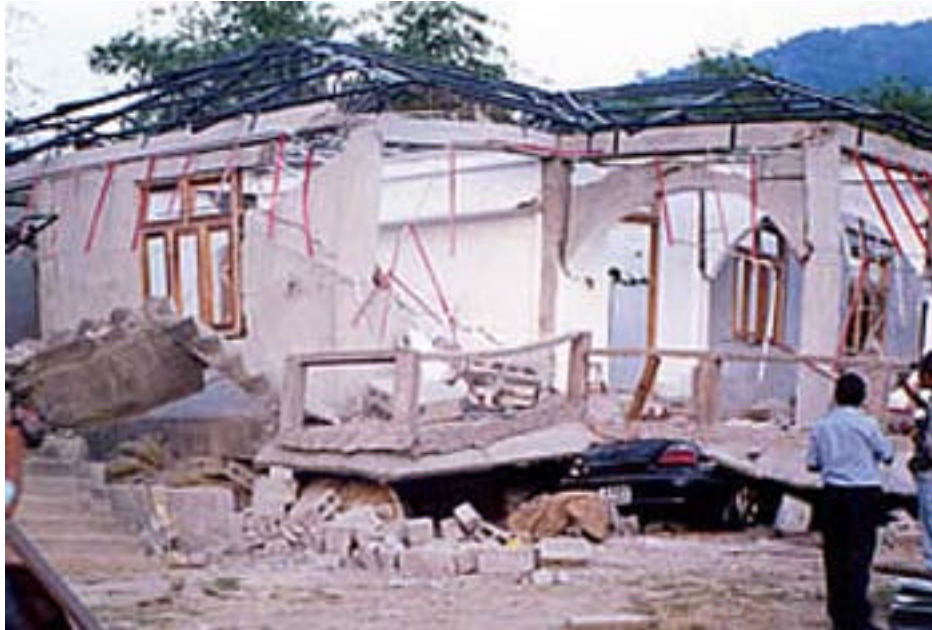
In the Kanyapuram locality one newly constructed house belonging to Mr. Hamid, was reduced to a heap of rubble. The two-storied RCC structure with GI roof completely caved in and a car parked in the ground floor completely crushed (Photo 5).

Photo 5: Complete caving in of the stilt and heavy damage of the first floor (now at ground floor level) of a newly constructed building in Kanyapuram. A car parked in the stilt got completely crushed

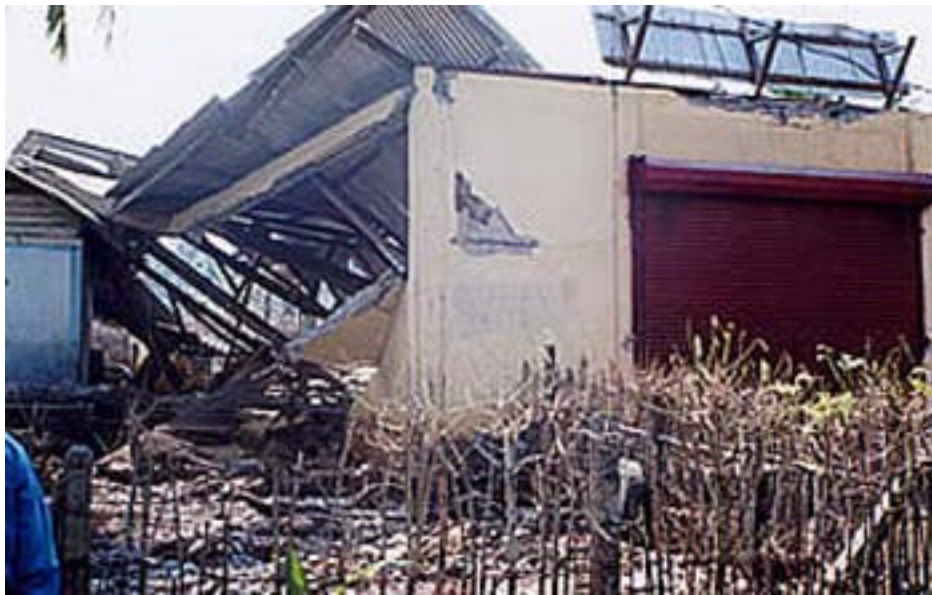
In the Ograbraj locality, a godown of Malabir Society was heavily damaged. This was a structure with approximate dimensions of 8 m (w) x 15 m (l) x 6 m (h). The walls were of hollow

concrete blocks with RCC columns at the corners and at the central parts of N-S aligned long walls. The slanting roof with GI sheets was supported by heavy wooden beams and rafters. The three walls and the roof suffered total collapse. The quality of construction was very poor, where steel used was found to be rusted and concrete of low strength (Photo 6). The area was subsequently inundated by the tsunami back flow (Photo 7). In the Collinpur locality, almost all the buildings suffered grade 2 or 3 damages. In a single case, a single story restaurant suffered damage of grade 5 in the form of total collapse of the structure. The long wall of the shack of GI sheet roofing seems to have thrust in N45°E direction. In this area, the foundation comprised clayey soil with shallow groundwater table.

Photo 6: Failure of the three walls and roof of Malabar Society godown, Ograbraj due to strong tremors

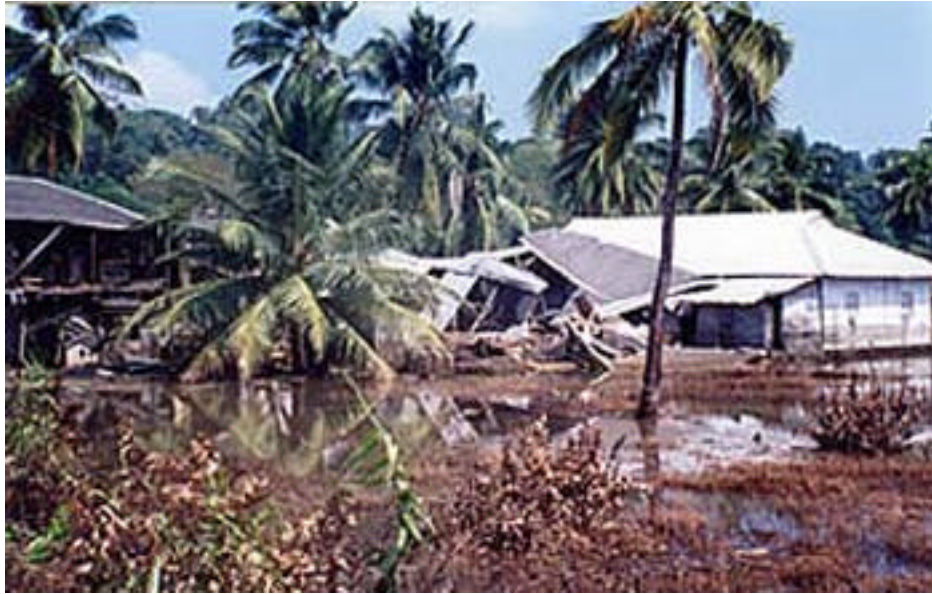
Photo 7: Inundation of the structure in photo 6 and surrounding buildings by the tsunami

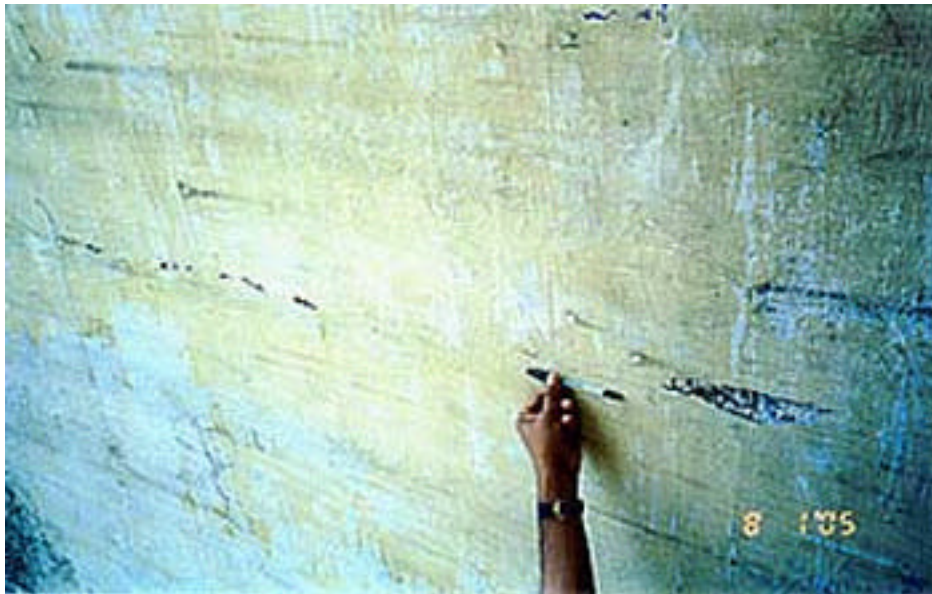
This water retention structure on Dhanikhari River was constructed during 1970-1973 for supply of water to Port Blair town. The dam is a 132 m long and 32.23 m high straight gravity –concrete structure with a central gated spillway having a capacity of 26,000 cusec. The reservoir extends to an area of 0.49 x 10 sq miles and the storage capacity is of the order of 9000 lakh litres. On 26 December 2004, the reservoir stood at R.L. 60.60 m. Inspection of the dam revealed some minor distress to the main structure due to the earthquake. Development of fine cracks and chipping off plaster along two of the right abutment block joints was visible (Photo 8). Inspection of foundation gallery showed cracking of the RCC along the fifth block joint, through which considerable amount of seepage was taking place. Some minor seepage was also coming from the right abutment slopes of the gallery. It was reported that prior to the earthquake, the water collecting in the foundation gallery used to be pumped after every six hours. After the earthquake and due to the increased seepage, it now requires hourly pumping. The reservoir water was also considerably agitated due to the passage of the shock waves as manifested by the seiche (standing water waves), which rose by as much as 3 to 4 m. After the earthquake, the main supply pipes were dislodged and therefore, in the initial days, the water supply to the town remained disrupted. It has later been restored.

Photo 8: Fine cracks and chipping off plaster at the block joints of Dhanikhari concrete dam

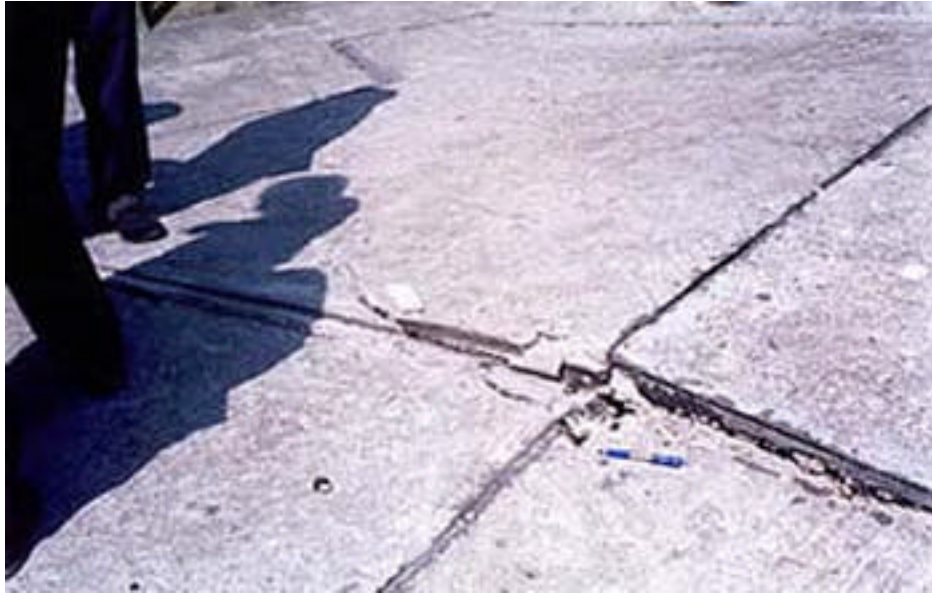
Chouldari water supply scheme is a 19 m high and 95 m long earthen dam structure with a 10 m wide and 80.58 m long left bank ungated RCC chute spillway. The earthen section has pitching of basalt blocks, both in the upstream and downstream sides. A concrete apron has been placed over the entire length of the crest. The distress to the dam on account of the earthquake is seen at the junction of the earthen section and spillway concrete. Here, the concrete apron has buckled by as much as 8 cm along the block joint (Photo 9). The profile of the earth section otherwise does not show any deformation or distress. It is reported that on 26th morning the reservoir level (reservoir area 15 ha) was quite low. But due to the tremors the waves in the

reservoir rose so high that they splashed on to the crest portion that was about 5.6 m above the reservoir level.

Photo 9: Buckling by 8 cm of the concrete apron at the interface of concrete spill way and earth section on the crest portion, Chouldari dam

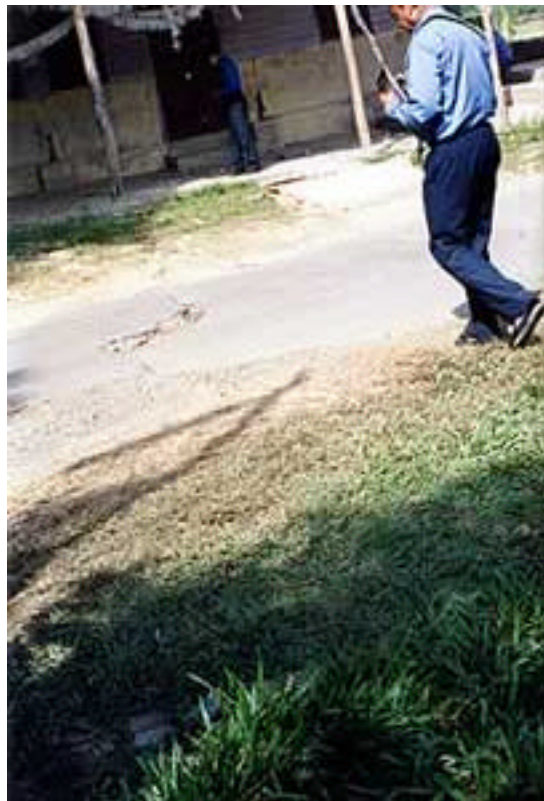
Ground fissures, slumping and subsidence were witnessed at several places in the coastal belt of Andaman Islands. At Collinpur locality, the fissures are arcuate in disposition, trends N-S and appeared to be a product of liquefaction and consequent lateral spreading (Photo 10). Here, the water table is barely a meter or less deep and the topsoil clayey silt. During the tremors, fissures were formed through which the ground water spouted. At a few places, cream-colored fine sand/silt also ejected out. As reported by the locals this zone of ground fissure continues intermittently for 6-7 km between Tirur in the north and Khurma beach in the south. A few buildings, which were founded over such a spreading zone suffered conspicuous damage. In a stray case, rolling down of a boulder from a hill has been reported at Collinpur. In the Baratang area the ground fissures are so pronounced that they damaged considerable stretches of the metalled road. These fissures are described below.

Photo 10: A ground fissure cutting across the road through Anganbari Community Centre, Collinpur

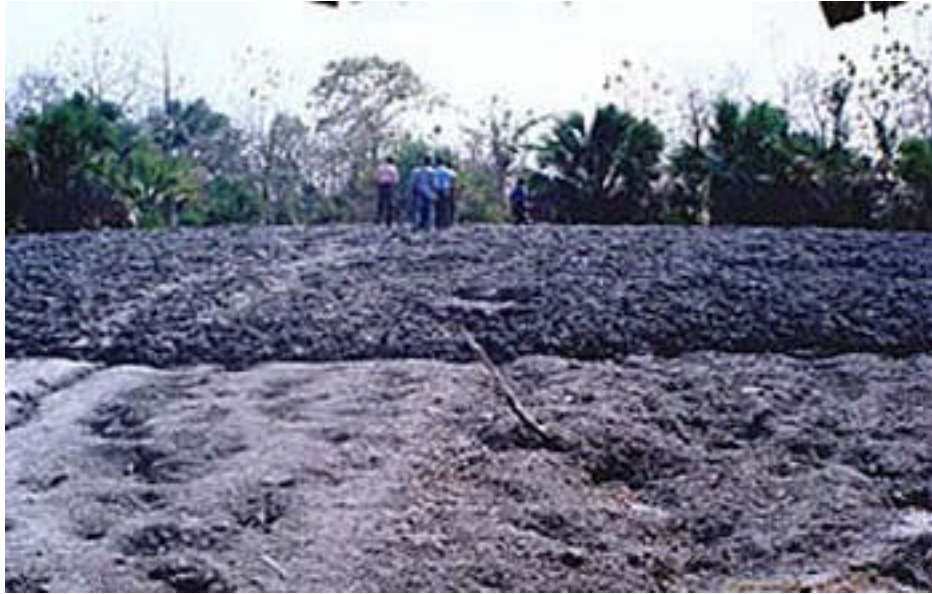
In the Island of Baratang, two major and some minor mud volcanoes among the chain of dormant ones erupted during the earthquake of 26 December 2004. Of the two major sites of eruption, the one in Jarwa Creek was examined in some detail. It is reported that soon after the major tremors, this volcano erupted with great violence. A series of explosions that lasted for several minutes accompanying the eruption could be heard from distances as far as 2-3 km from the site. A resident of Rajatgarh village narrated that he saw the mud splashing to above the forest tree height. At the eruption site on the following day he witnessed flames coming out of one vent. During the present study the site was visited after 17 days of the eruption. The mudflow of 26th December 2004, has spread in an area of around 10,000 sq m and had a very distinct bulged contact with the older mudflow (Photo-11). The shape of the mudflow can be described as that of a flattened bun. The main crater, located at the center of the mud deposits was no more active. Gases along with small quantity of sticky and viscous mud was still coming out in fits and rhythms through another newly formed vent located about 10m away from the previous one (Photo-12). Blowouts with an average frequency of 2 minutes accompanied by low blurring and hissing sound, was audible from a distance of 10 m or so. This crater is about 0.75 meter in diameter with a vent of about 20 cm at the center.

Photo 11: Mud volcano that erupted after the 26th December 2004 earthquake in Jarwa Creek, Baratang. The recent mudflow has a distinct contact with an older flow

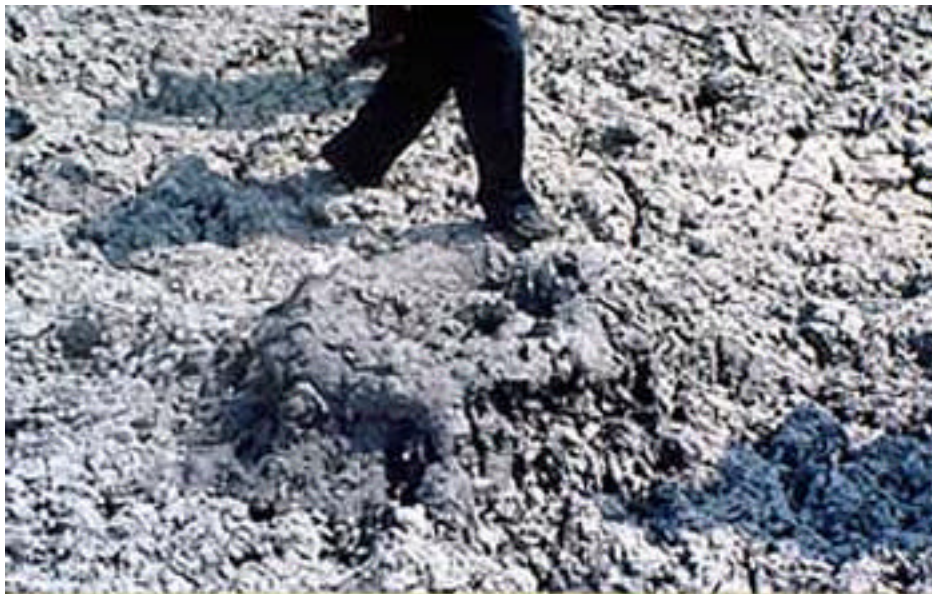
Photo 12: An active crater within the recent mud volcano

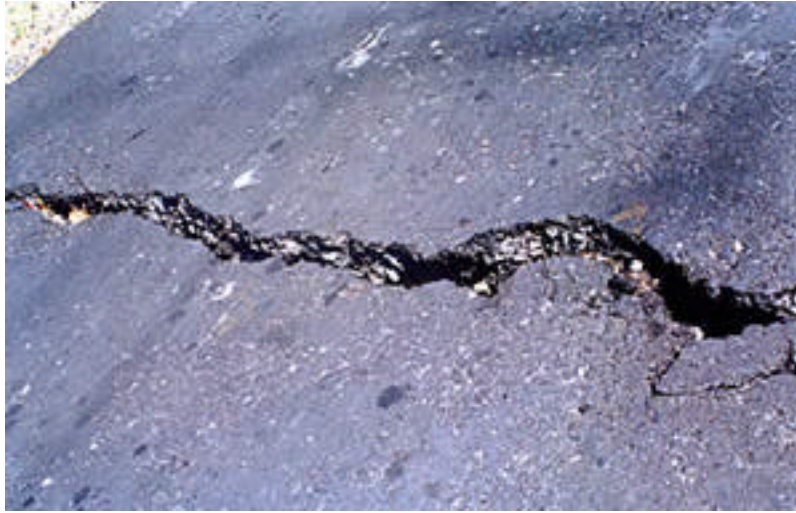
About 500-700m metalled road stretch from the mud volcano site towards Baratang Divisional forest office is highly fractured. These open fractures trend N25E, cut across the road (Photo 13) and continue on either side on ground as irregular fractures. Both right and left lateral slip of 5 to 10cm observed on the edge of the road. In this stretch at one place the black-topped road surface has buckled up to develop as an antiform with height at the axial region of 25-30cm. Almost parallel to the road a 90 cm to 1.5m wide surface fracture trending N55W continue for about 50m and join with one of the fracture that cut across the road. In this stretch a healthy long tree with its roots was found neatly split vertically into two parts and shifted horizontally (Photo 14). While the left hand portion of the tree remained almost in situ the right hand part was displaced about 1.20m diagonally towards north, thus showing left-lateral shear. The horizontal component of slip along the fault plane is about 85cm. Close to the intersection of this fault and the fractures cutting the road a newly formed small mud volcano with a distinct crater was seen. Through the pulsating vent small amount of odorless gas and wet clay with a film of black colored odorless substance were spouting at regular interval. In two nearby sites minor quantity of gas was continuously escaping from pool of water.

Photo 13: Fissure developed on the road at Baratang

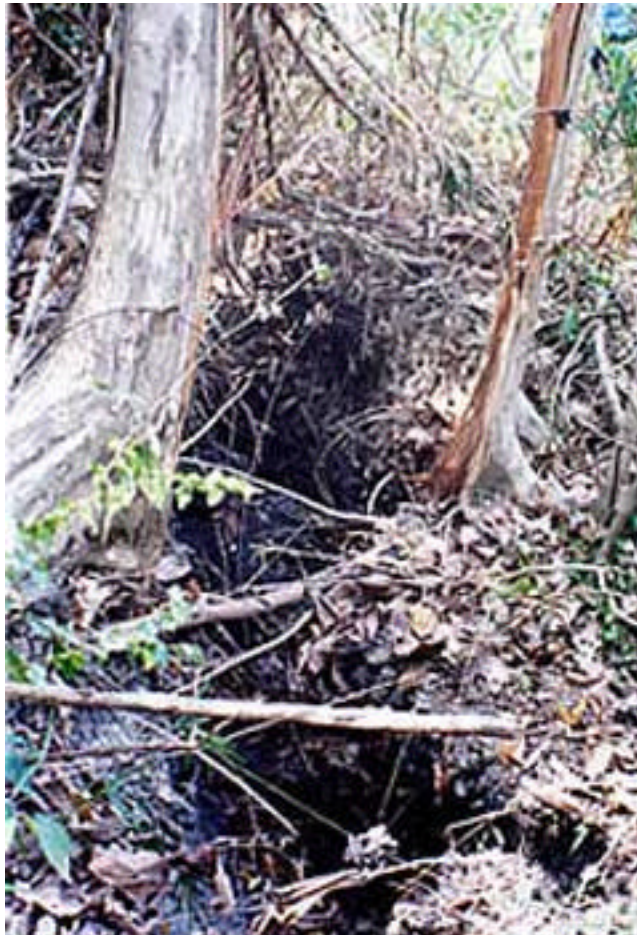
Photo 14: A tree trunk with its roots separated into two halves along a wide open (90 cm) crack. The right side part of the trunk shows left lateral shear

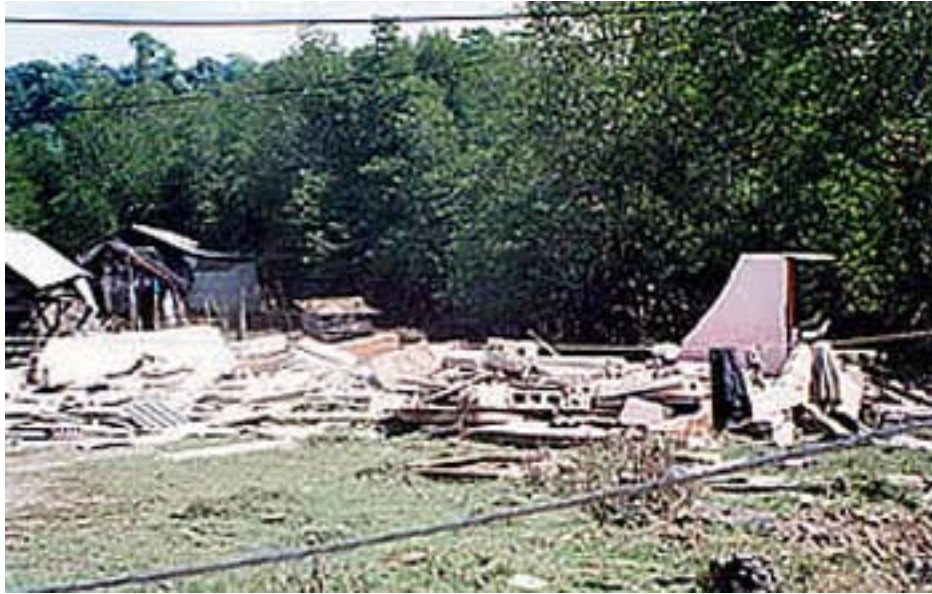
Photo 15: Structures flattened by the tsunami in Wandoor

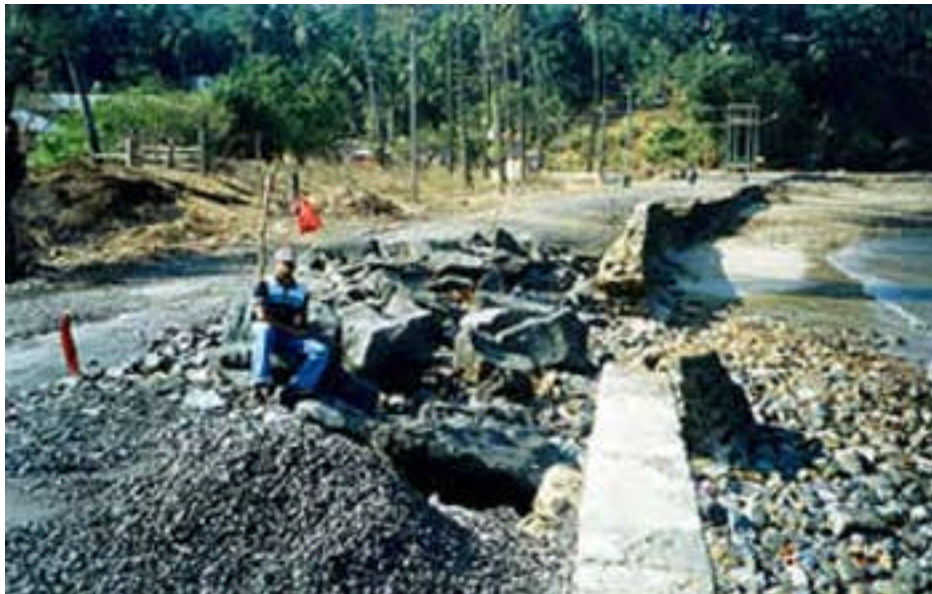
Photo 16: Breach in a section of the shore protection wall at Nazar, Port Blair

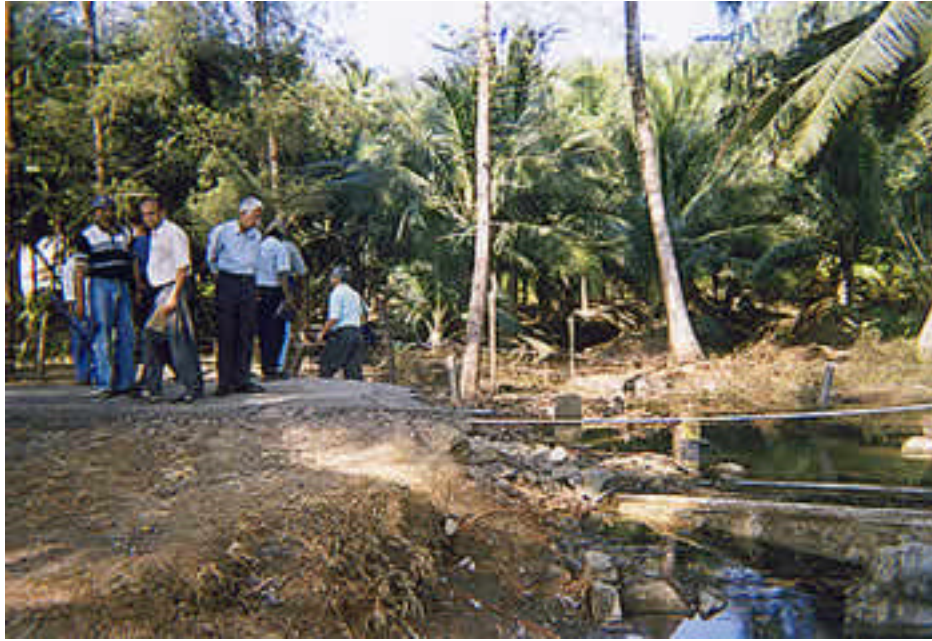
Photo 17: Washing away of a bridge by the tsunami at Corbyn's Cove, Port Blair

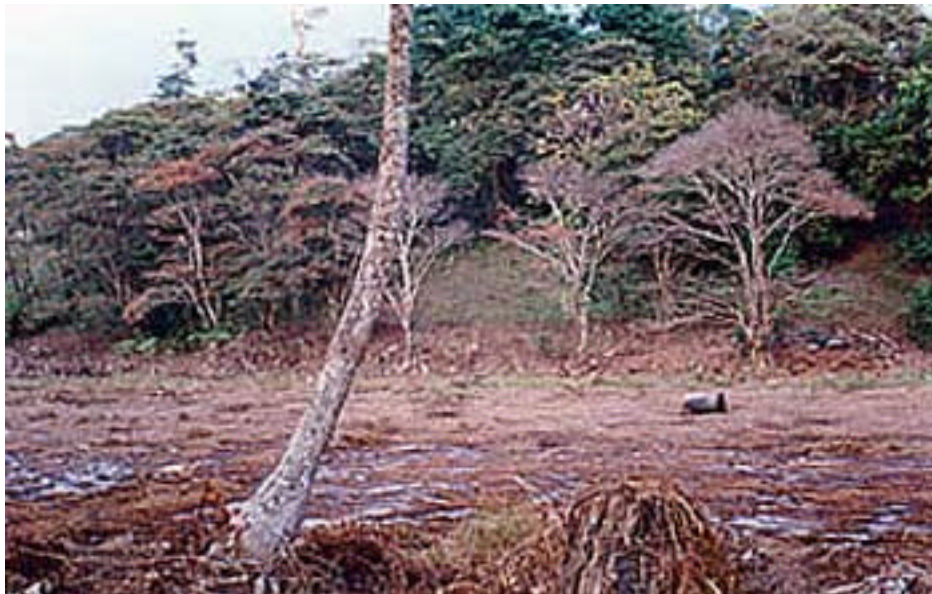
Photo 18: The tsunami water mark (brown – green interface) about 2m above the high tide level at Chidiyatapu

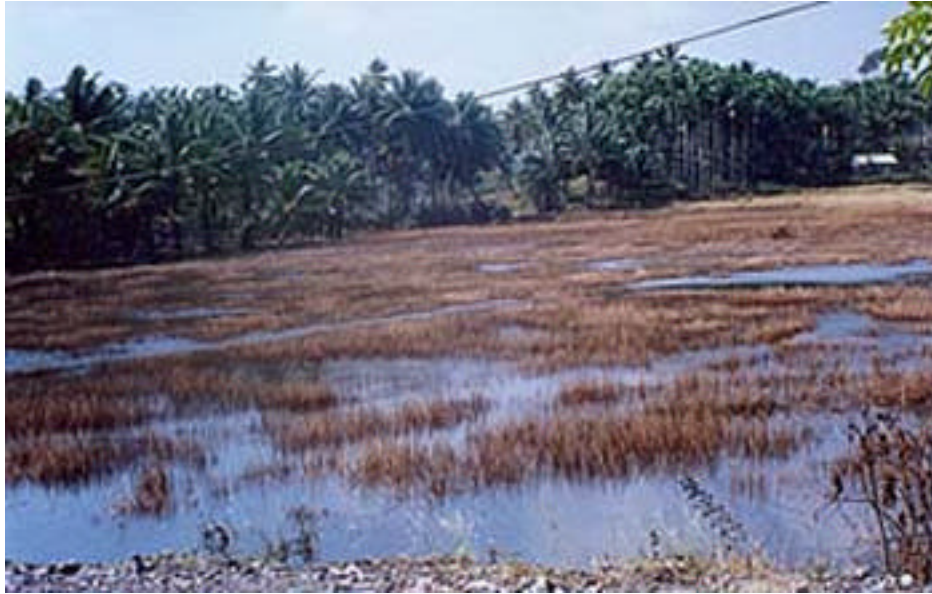
Photo 19: Inundation of a paddy field through the backwaters in Ograbraj
