Kathmandu Valley Shaking Intensities Gorkha earthquake 25 April 2015

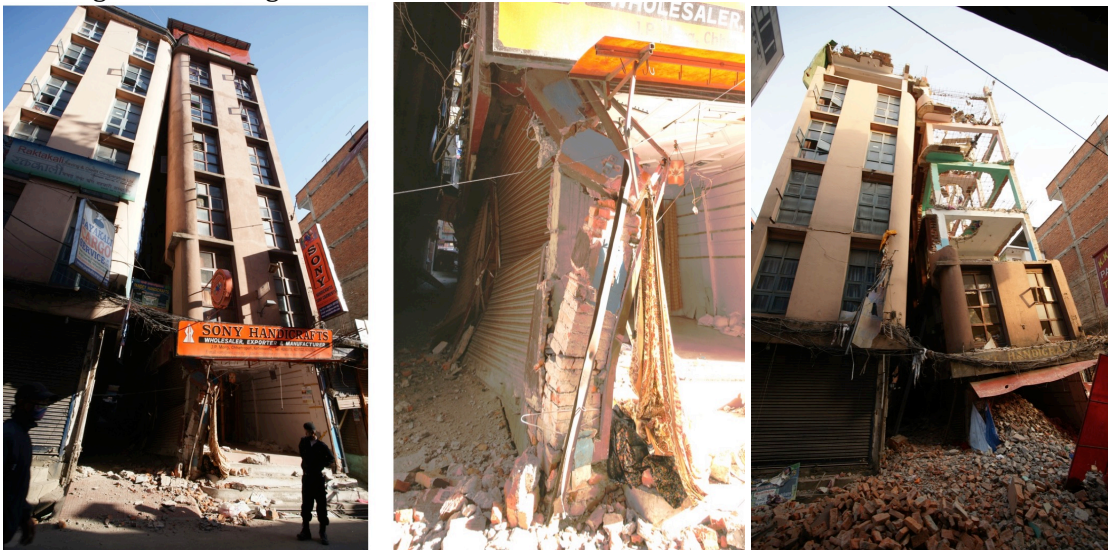
One example of a partial 7- story soft story RCC collapse is described. The owner's father insisted on a well constructed building. A foundation raft of concrete 7 feet thick was apparently poured (the owner described this as a solid block but the amount of concrete required for its 7 m width and 20 m depth from the street would seem excessive). Engineers were involved in the design, and the assembly was inspected at every stage by government building inspectors. Finally the building was insured against earthquake damage. The building was supported by columns on each side and by five or more extending back from the street. During the earthquake three of the left columns fragmented (weak cement and insufficient stirrups) and the building tilted and leaned against what appears to be an identical construction with just 6 stories. This adjacent building was damaged by the sideways impact of the 7 story building in the mainshock, and further damaged in aftershocks. The owner emptied the building and dismantled it top down over a period of 6 weeks. Some or all of the adjacent building needed dismantling. No other RCC buildings were damaged within almost a 1 km radius.

A rare RCC collapse in Thamel –left a week after the earthquake. Right partly dismantled two months after the earthquake. Center: front left hand column collapse.

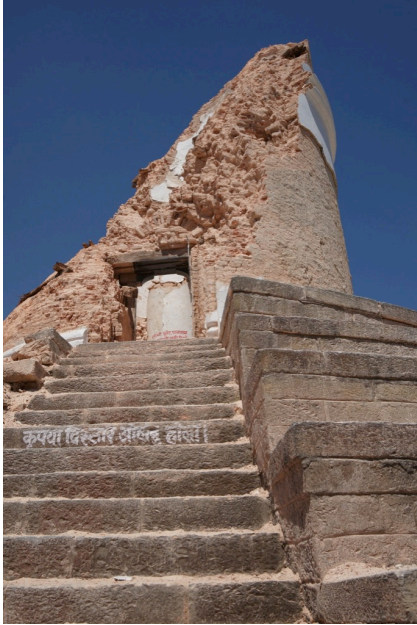
South of Thamel the Bhim Sen tower collapsed killing all visitors to the building (midday Saturday). This is third time the tower has been damaged but only the second time it was razed to the ground (1833 and 2015). Buildings in the region immediately north of Thamel were not damaged except near the river and damage became intense near the ring road bridge across the Bishnumati river and the bus station. Here damage to RCC buildings was severe but over a limited region. Undamaged RCC structures could be found within 200 m of those with severe damage.

Base of Bhim Sen Tower after it had been cleared of debris. The Bhim Sen tower (one of two) was constructed in 1825 and reconstructed after the 1833 earthquake. Its sister tower was not reconstructed. It escaped damage in 1866 but partly collapsed in the 1934 Bihar/Nepal earthquake and was again repaired, but totally collapsed in 2015. The Bhim Sen tower was most recently known as the Dharahara tower.

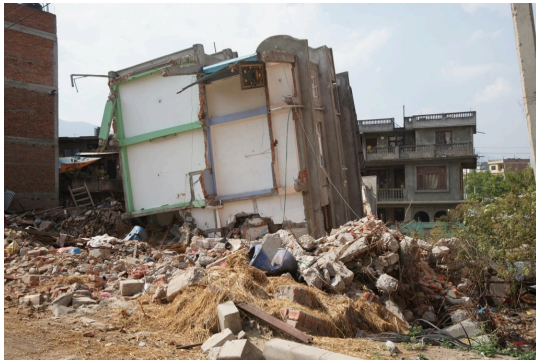
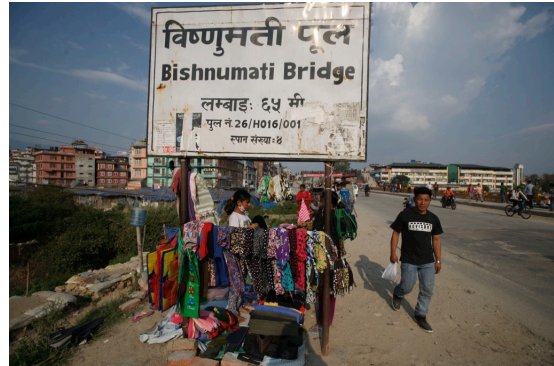
Left views of the exposed ceilings of RCC building above the west bank of the Bishnumati River (1 km south of the bridge right) that has topped downhill and rotated 90° during collapse. A cluster of buildings here (less than 5% of the total), suffered lower story damage (e.g. lower right) but the bulk of the surrounding RCC buildings were undamaged. Brittle steel was evident in the columns with insufficient and poorly tied stirrups.
