Search for Gorkha earthquake surface rupture 4 May 2015

Locbijay Adikhary, John Galetzka and Roger Bilham

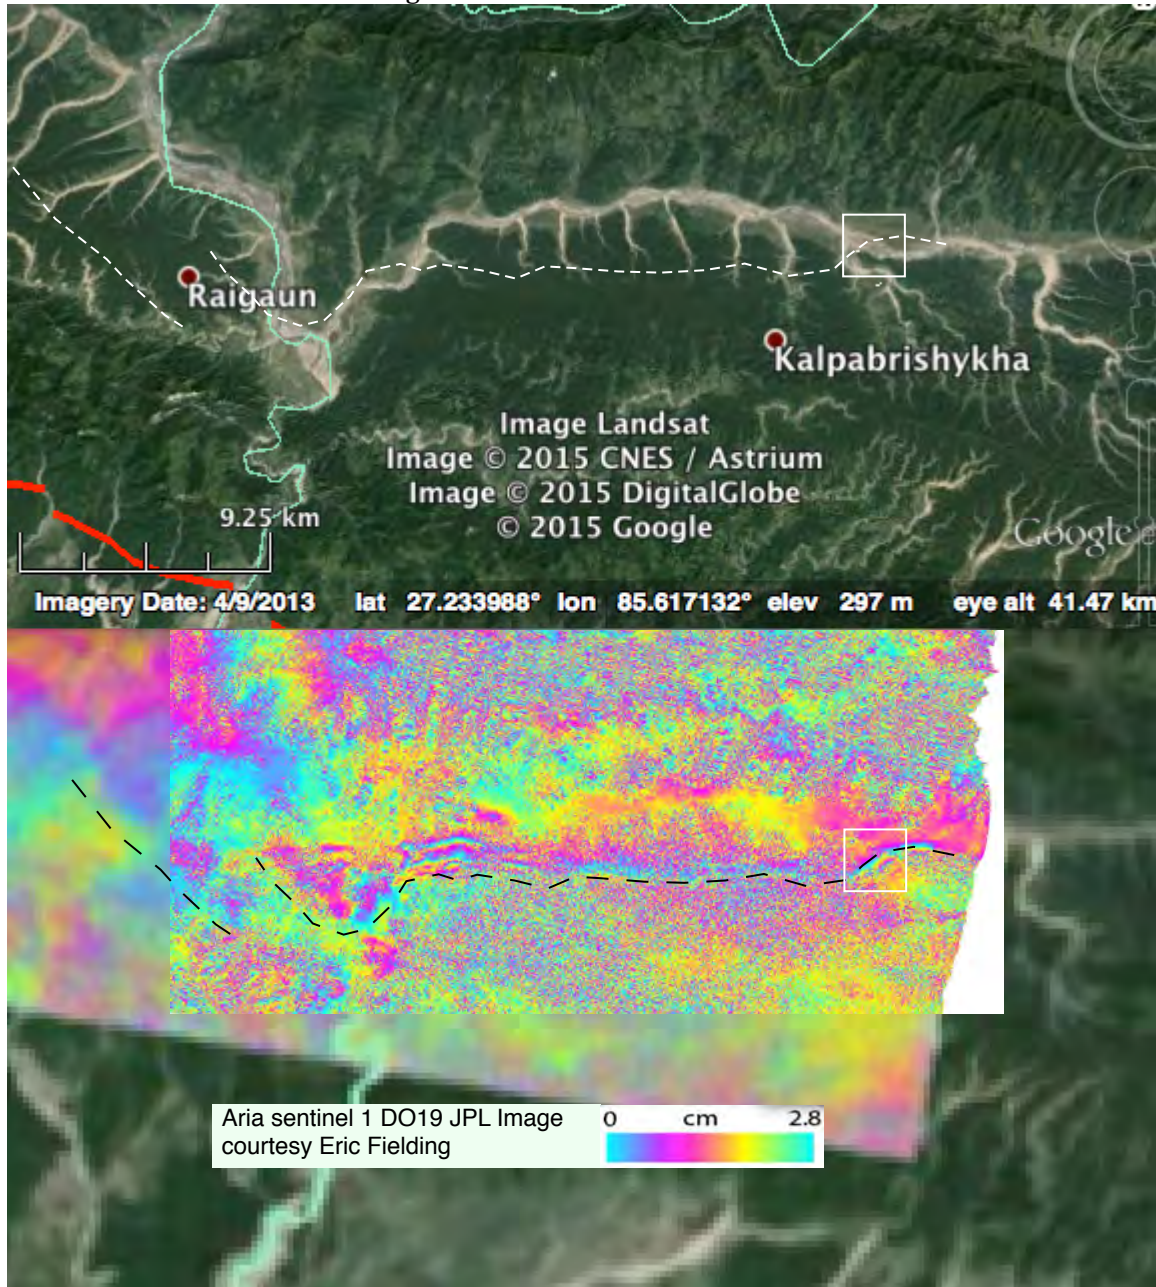
Figure 1. Image of 2-5cm dislocation in 1 May Aria Sentinel 1 scene (provided by Eric Fielding) for which we searched 4 May (white box shown in Figure 2).

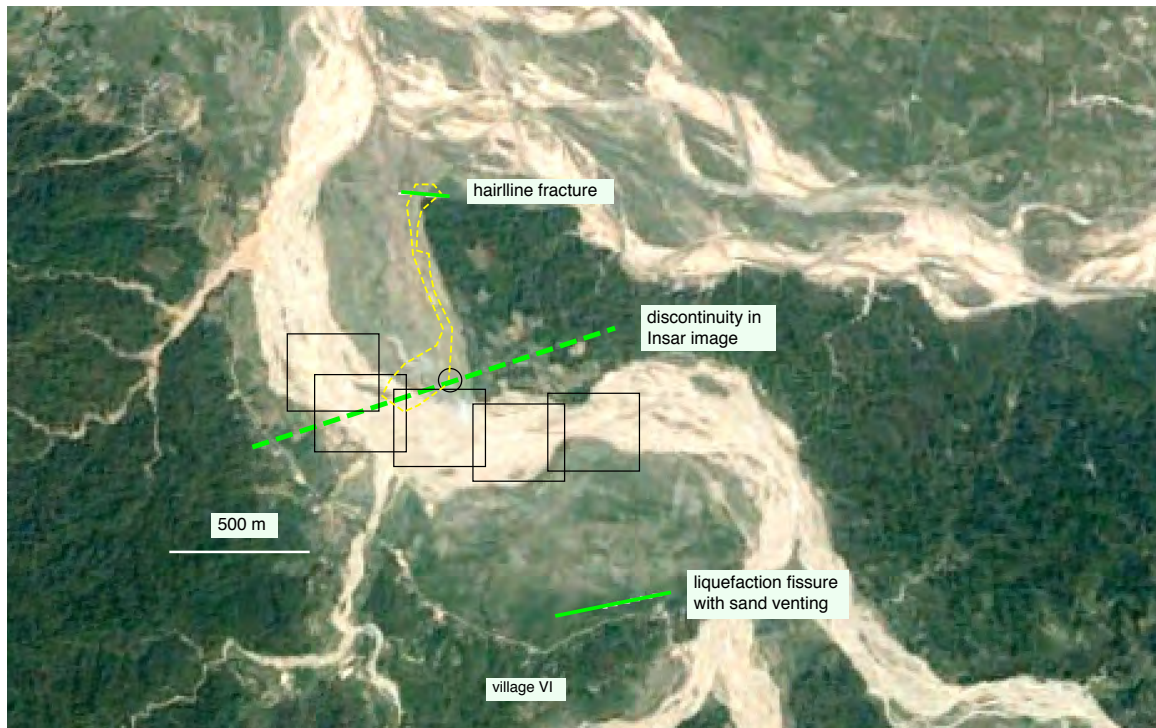
Figure 2 Close up of inset region shown in Figure 1 consists of a 2-km-wide, anastomosing river channel with fields of agriculture near its edges leading to forested slopes of hummocky Siwalik hills. The approximate path of the Insar discontinuity is shown by a green dashed line. Black circle is landing spot for helicopter. Cracks identified by villagers shown as solid lines. Black squares approximate locations of 26 Megapixel images. Yellow dashed line region inspected on foot.

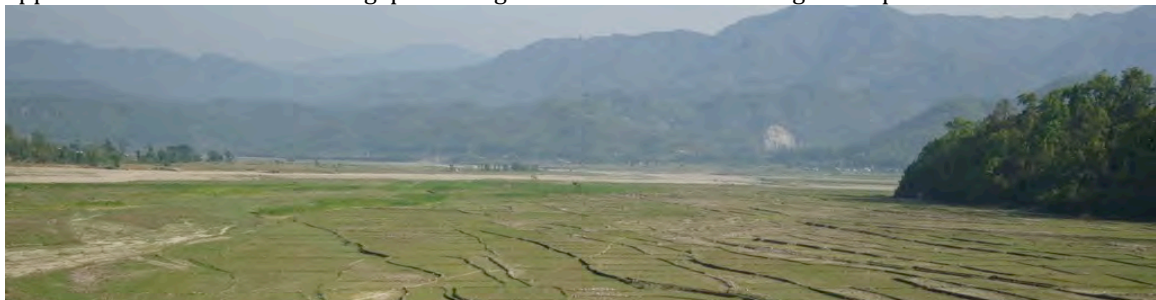
Figure 3 View north from the westernmost black box in Figure 2 at approximately 100 ft elevation.

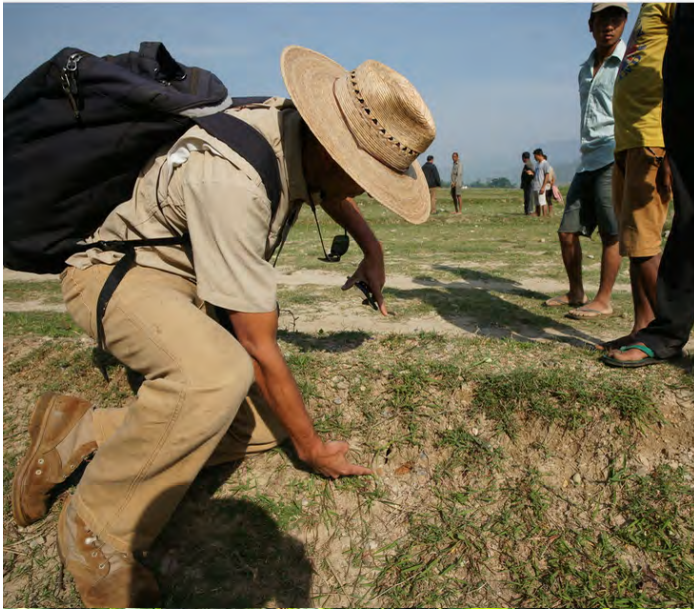
The hairline fissure was east-west and about 10 m long and barely visible (ten days after the earthquake) where it had cut recent vehicle tracks in mud. It lay on eastern edge of the flood plane of the river close to the edge of a north-facing slope where it petered out amid a stiff clay covered hillside covered by bushes and trees (near the forested bluff on the right in Figure 3). No vertical or lateral offset was evident in this fissure.

Figure 4. Hairline fissure to north of initial search area viewed looking west.

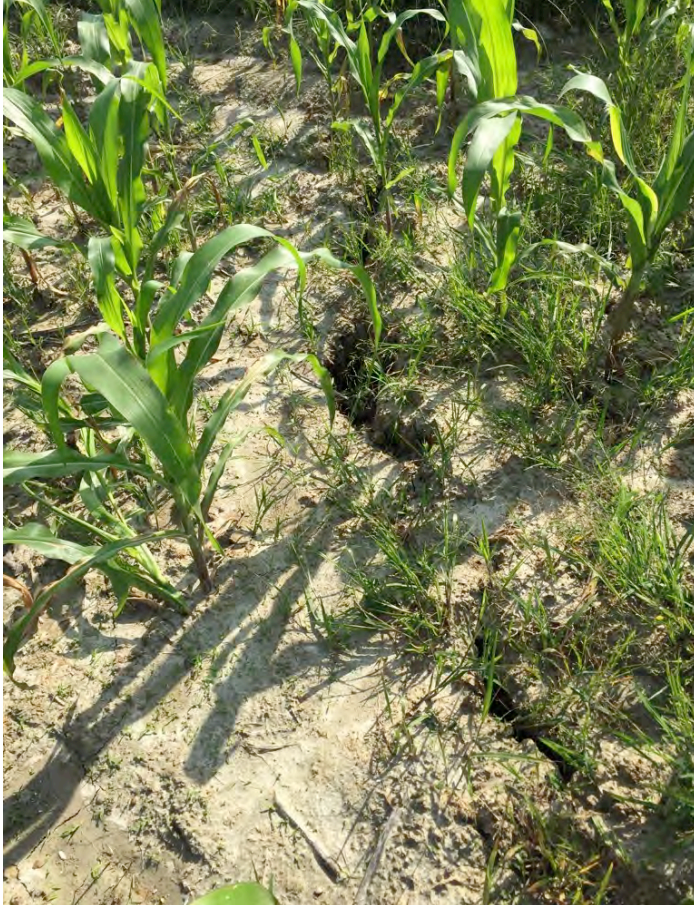
The second fissure was also east west and about 650m long and was initially reported to exceed 10 cm in width and 2 m depth. It cut through a field of maize and passed near a cylindrical, concrete-lined water well. During the earthquake (shortly after shaking commenced) both the well and the fissure expelled water and silt. After some tens of minutes this ceased and the fissure closed. The well was dry when we visited it. A thin layer of silt now covered the field downhill from the fissure, that at the time of our visit was nowhere wider than 2 cm. It is possible that the soils across the crack had been offset by 1-2 cm down to the north.

Figure 5 (left): Liquefaction crack with silt covering soil layer.

We deduced that the fissures in the river bed had resulted from shaking and liquefaction during the earthquake. An attempt to follow these fissures to east and west from the air was unsuccessful since their projection led to forested rough terrain (Figure 6), where it was impossible to land a helicopter or to view through the trees.

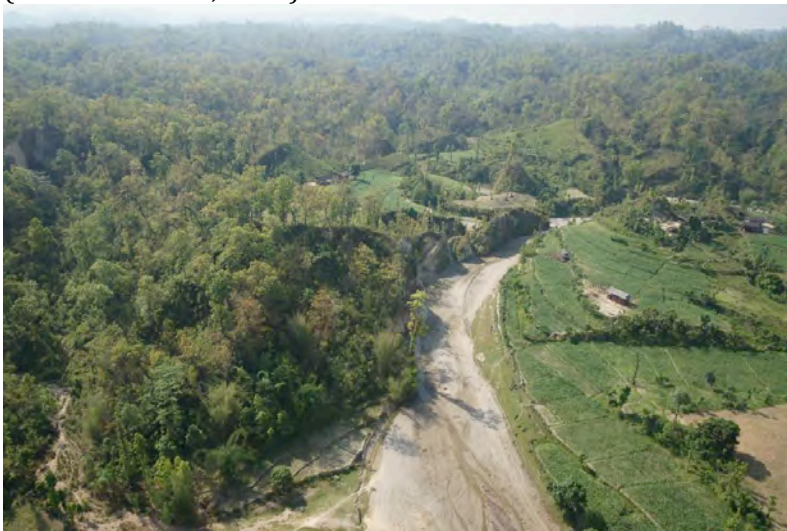
Figure 6 View west from study area showing forest cover and hummocky terrain and an absence of landing sites.

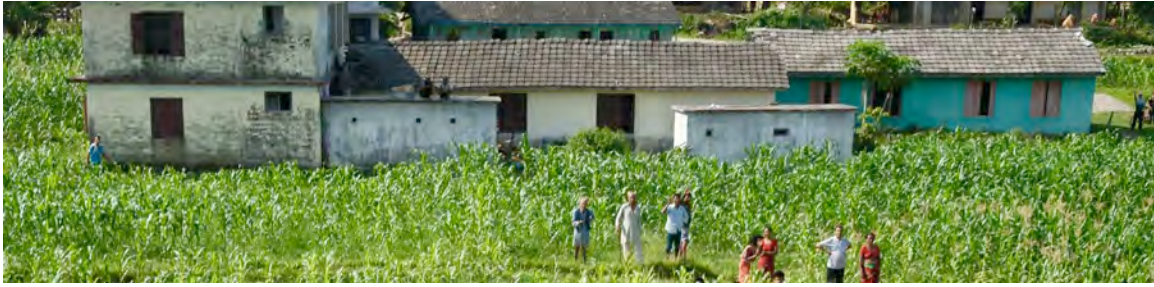
Figure 7. Masonry structures (200 m south of the liquefaction fissure) showed no evidence for damage except of the loss of a few tiles near end gables (Intensity 5-6).

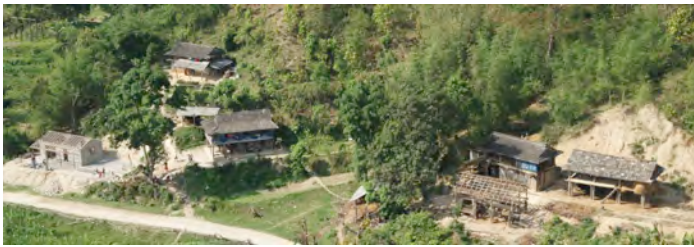
Figure 8 Damage to one roof (lower right) Building under construction (left)

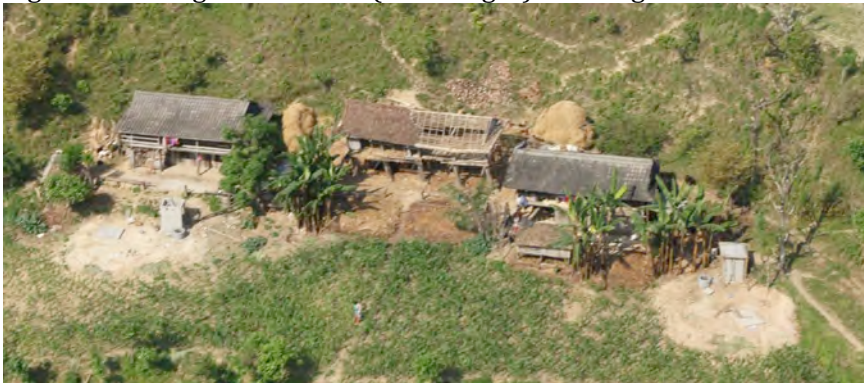
Figure 9 Damage to roof and wooden pillar soft storey misalignment in central building.

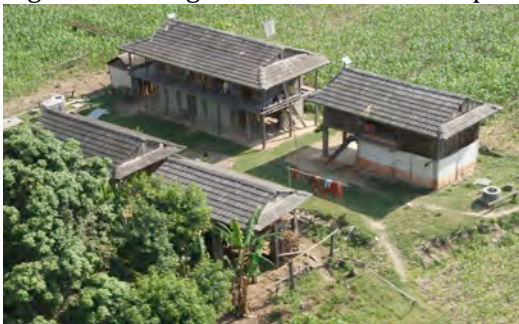
Figure 10 No damage to masonry ground floor or wooden superstructure and roof.

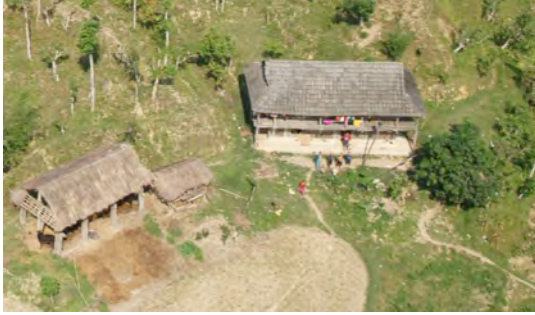
Figure 11 No evident damage to lightweight soft story barn. Possible loss of end-porch roof cover lower left.
