Preparing DAWN for Future Airborne Campaigns

John Marketon

NASA Langley Research Center, Hampton, Virginia 23681

7-8 Feb 2018

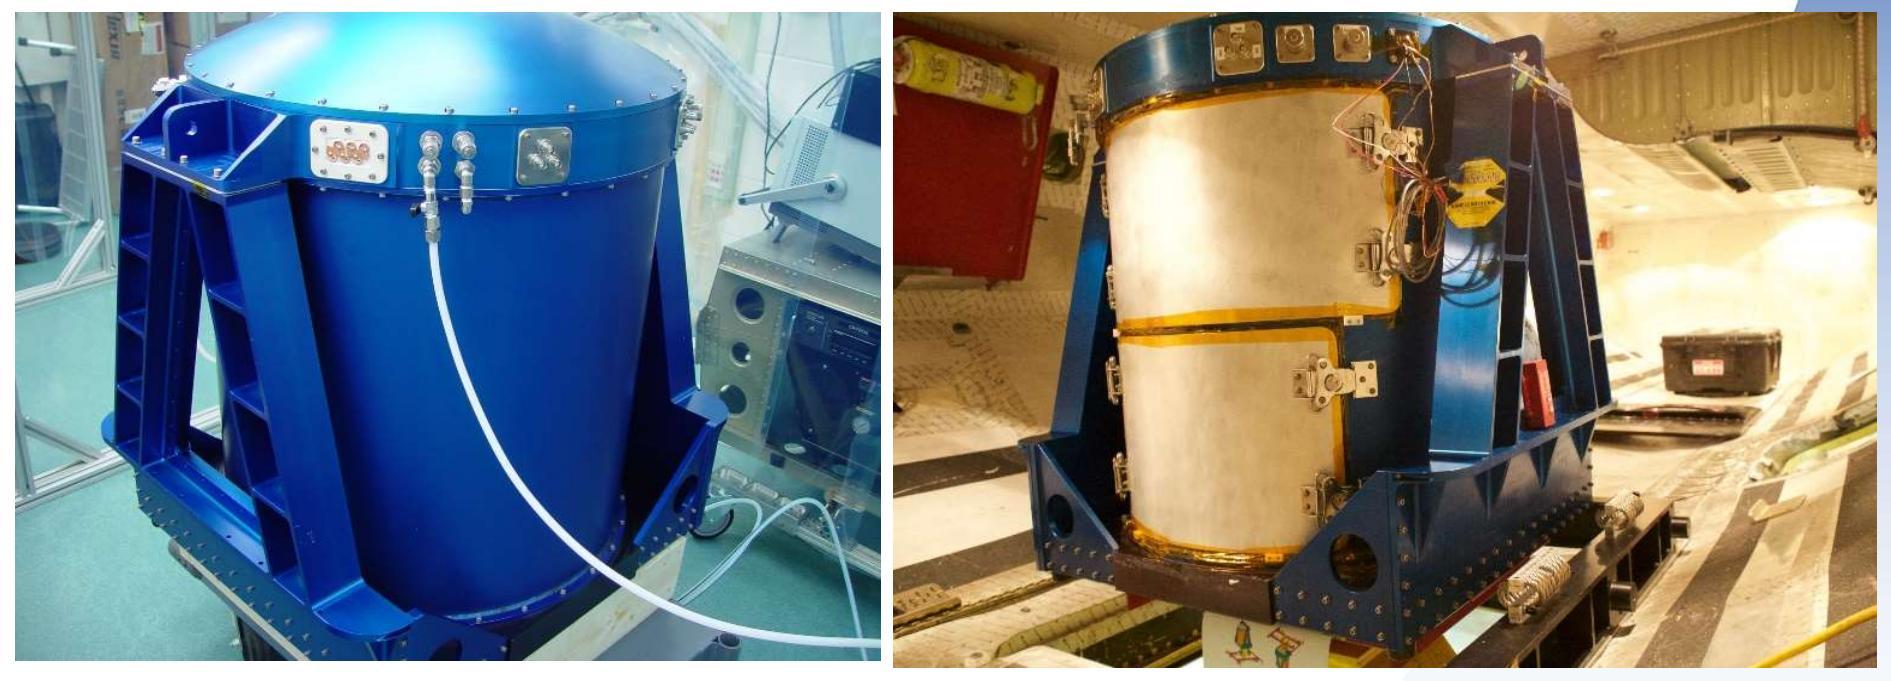
Mechanical modifications for improved accessibility

- Limited access pressure vessel not needed on DC-8
- Access ports cut into enclosure, covers & alignment jig fabricated
- Internal obstructions removed
- Assembly stresses impacting optical subsystem alignment reduced/eliminated

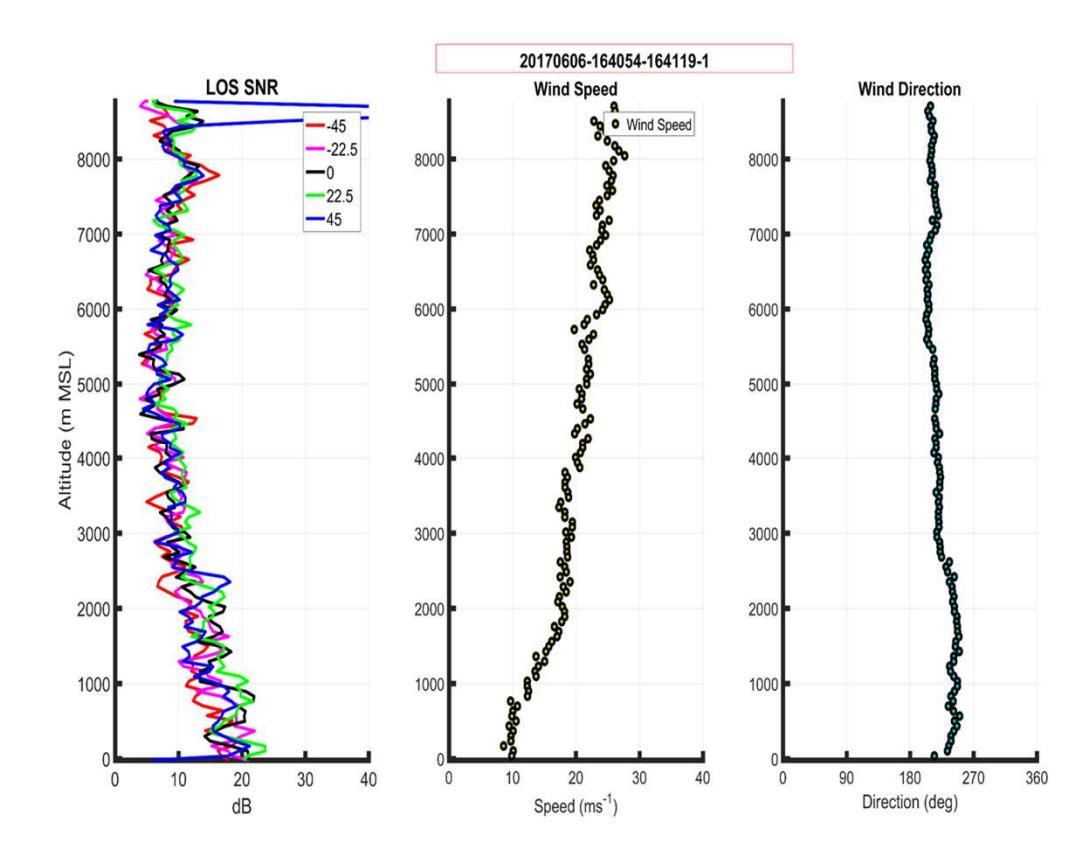
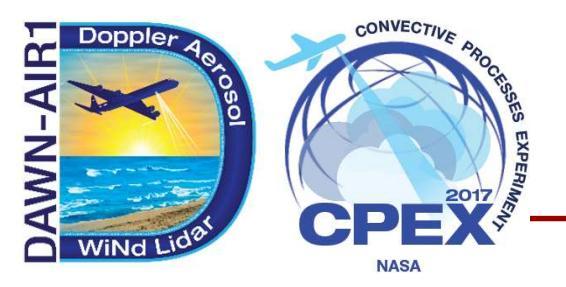
Optical repairs & improvements (with Beyond Photonics)

- Malfunctioning fiber network repaired
- T/R beam size, curvature, & alignment corrected

\geq 10 - 15 dB improvement (Polar Winds 2015 \rightarrow CPEX 2017)

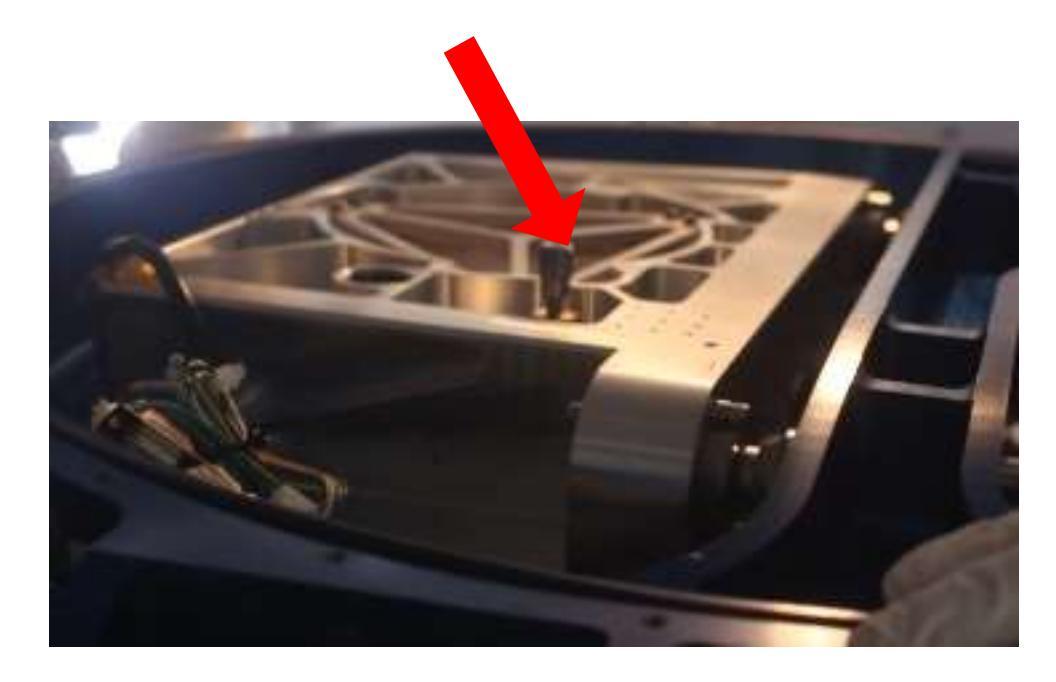
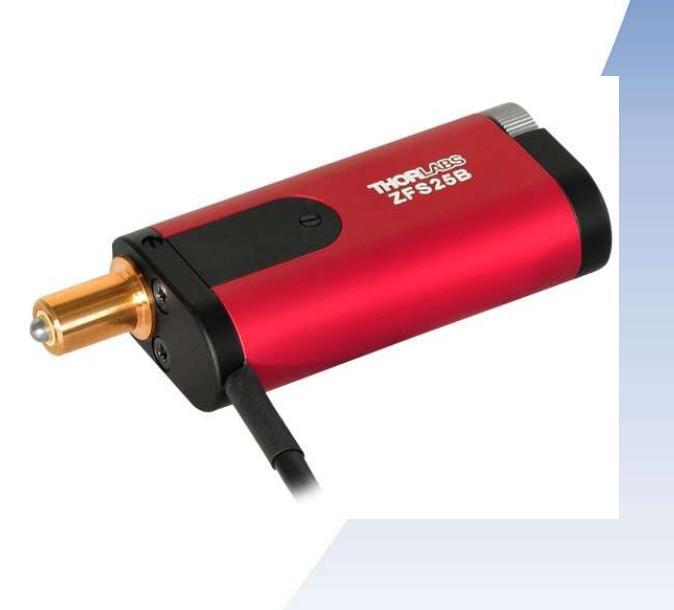
Telescope Focus Remote Control

Replace manual micrometer with motorized actuator Enables focus adjustment to flight conditions
