A ninth century earthquake-induced landslide and flood in the Kashmir Valley, and earthquake damage to Kashmir's Medieval temples

Roger Bilham & Bikram Singh Bali

Bulletin of Earthquake Engineering
Official Publication of the European
Association for Earthquake Engineering

Bull Earthquake Eng
DOI 10.1007/s10518-013-9504-x

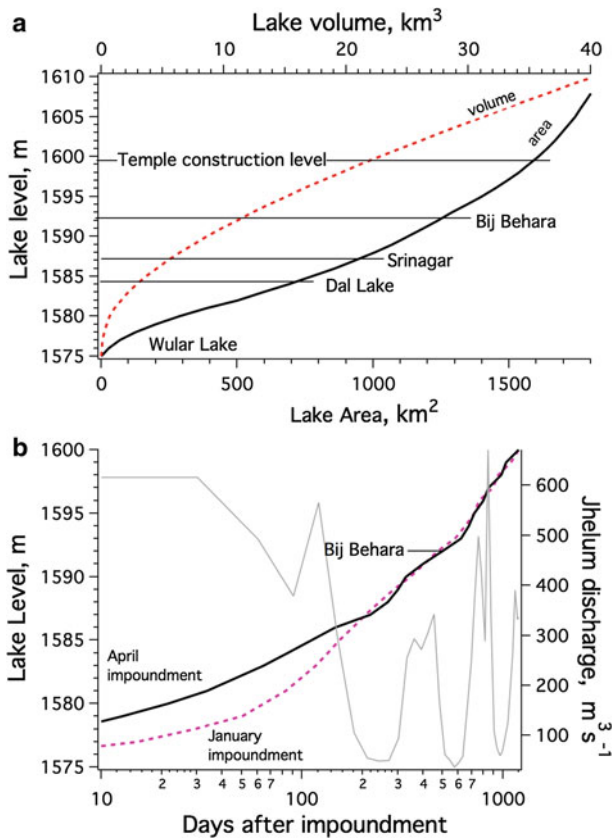
Fig. 3 **a** Lake capacity (dashed) versus lake area for the Kashmir Valley for floods 0–35 m above basin exit level. Seven Medieval temples are located at $\approx 1,600$ m elevation. **b** Time taken (logarithmic time scale) for the valley to flood to the 1,600 m contour (25 m-depth) using realistic discharge rates (grey line = observed April 1973–July 1977 discharge at Baramula). The dashed line assumes impoundment following a landslide-induced dam that occurs in late December (minimum discharge), whereas the solid line assumes impoundment starting in April at the time of maximum discharge

the Kashmir Valley to Bij Behara (17 m above the level of the Jhelum where it exits the valley), cannot be < 2 years whether flooding commences in January or in April using typical discharge rates (Fig. 3b). Although it is possible to envisage extreme summer melt rates exceeding those tested ($650 \text{ m}^3 \text{ s}^{-1}$) it is unlikely that Medieval discharge rates during winter months were substantially higher than in the past century. We note that Srinagar, the capital of Kashmir, would be flooded to a depth of approximately 5 m at the time that flood waters overlapped Bij Behara (Fig. 3a).

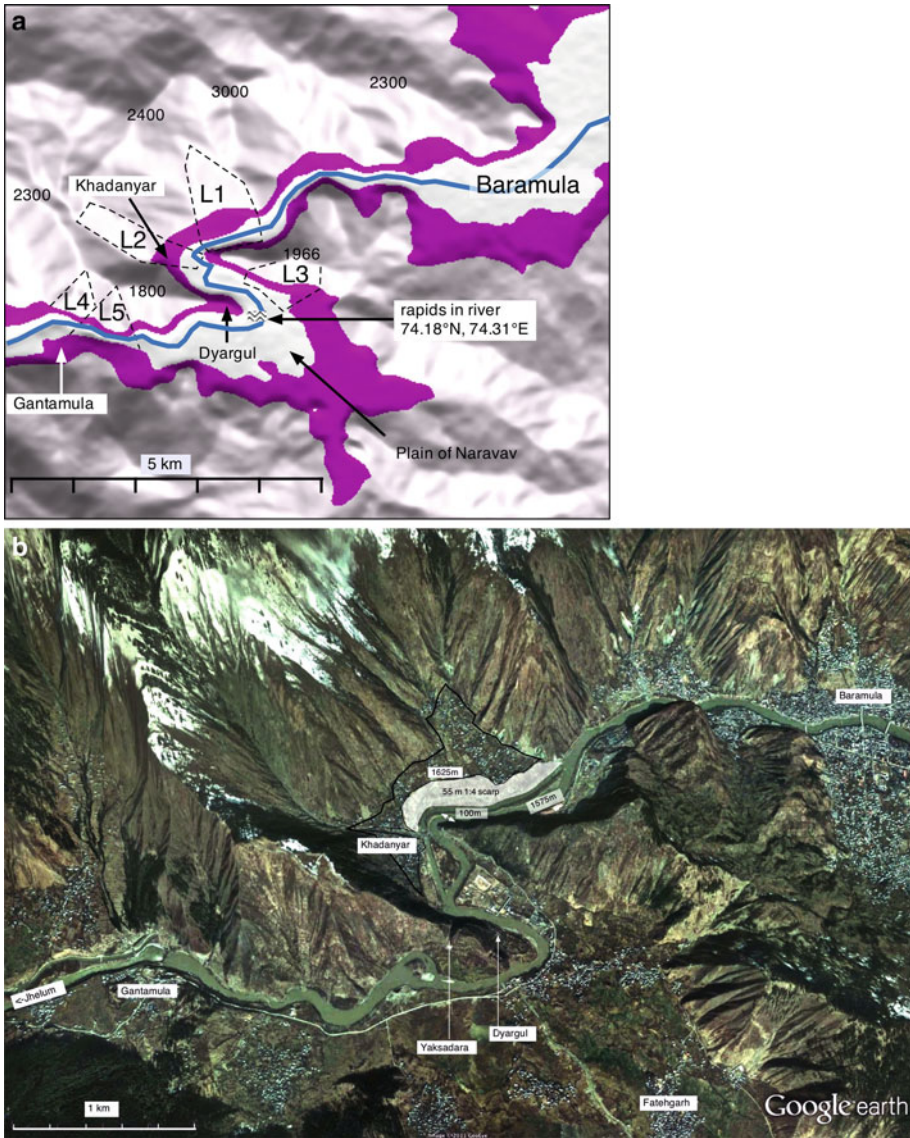
Fig. 4 a The path of the Jhelum downstream from Baramula with river terraces above 1,590 m and below 1,650 m shaded. The lower contour (1,590 m) is the minimum height of a landslide required to flood Bij Behara in the Kashmir Valley. South-facing scars are indicated L1–L5 with numbered spot heights in m. Note the constricted channel width below L1, L4 and L5. AV-shaped notch affords passage through the Dyargul ridge near the point of the arrow, which was identified by Stein (1899, p. 85) as Yaksadara—the demon’s cleft. The river falls from 1,575 m near Baramula to 1,560 west of Gantamula, but most of its descent occurs below the rapids at Dyargul, mapped by Montgomerie Montgomerie (1858, 1886) b Google Earth oblique view of the Jhelum gorge below Baramula. The scarp eroded by the river through the landslide deposit NE of Khadanyar (shaded) attains a height >50 m

The *Tarikh-i-Hassan* account also provides a specific location by mentioning the “ridge of Khadniyar” above Baramula. Khadniyar (Khadanyar) on present-day maps (Fig. 4a, b) is backed by a low ridge to its south which rises westward from the river level to 2,300 m, and continues north of the village as a ridge towards Baramula exceeding 3,000 m. The river

channel NE of the present village of Khadnyar cuts through a 20 m high triangular-shaped present-day alluvial fan (Fig. 4, L1 fed by numerous small streams. The 1 km-long incised section along the front surface of the fan reveals it to include unsorted blocks of angular

Landslides occur most commonly on south-facing slopes in the Himalaya and Pamir (Ambraseys and Bilham 2012). Such slopes are most exposed to freeze-thaw conditions and are largely devoid of forest. In Fig. 4a we identify five steep south-facing scars and the inferred paths of the landslides that could potentially block the Jhelum. Of these L1 is the largest but we consider its location too far east to be consistent with *Suyya*'s second deposit of coins. A landslide at L2 would have buried any town in its path, but it is possible that a new town with the same name may have been established long after the landslide. The present village of Khadniyar lies at 1,590–1,600 m elevation and a historical landslide here could have blocked the 300 m width of the Jhelum where it follows an acute bend from westward to southeast flow.

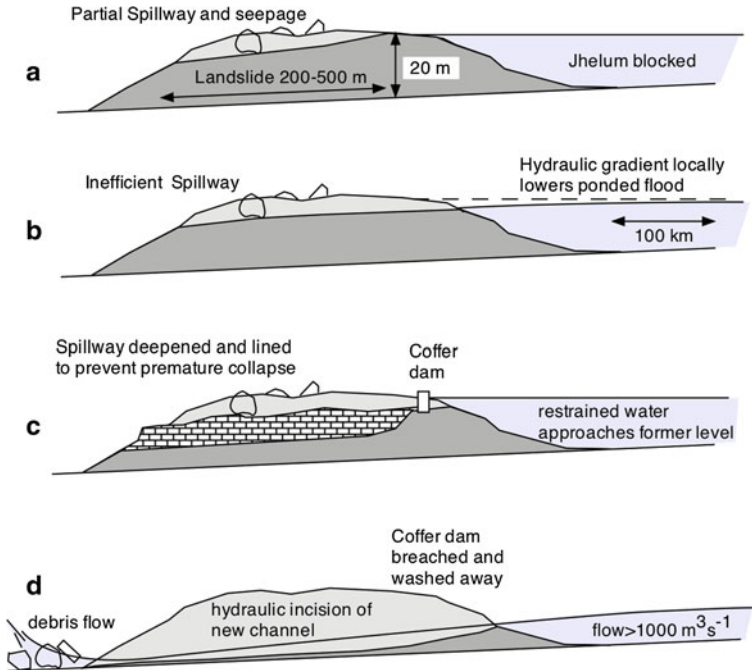
Fig. 5 Possible sequence adopted for removal of the Medieval Jhelum landslide. *Suyya's* initial spillway (a, b) which drained for 3 days may have been inefficient and difficult to deepen, causing him to build a coffer dam (c), and to dig and line a narrow spillway through the bulk of the slide, avoiding large rocks too heavy to move. By destroying the dam (d) after forming a deep spillway through the landslide, he was able to enlist the erosive power of fast running water to deepen and widen the spillway, leading ultimately to the return of the stream channel close to its former level

This interesting sequence offers several interpretations of which we propose the following. The waters appear to have been lowered in verse 89 sufficient for the villagers to recover some but perhaps not all of the coins thrown into the waters near Yaksadara. Had this first stage of clearing the dam been attended by, say, a 5 m lowering in the crest of the dam, it would have permitted the drainage of roughly one third of the volume of the floodwaters then stored in the Kashmir Valley, but this could not have occurred in less than a few weeks given the low hydraulic head, large reservoir volume and restricted channel width. This estimate is based on the following considerations. The observed discharge rate of natural dams with an initial hydraulic head of <20 m during breaching is typically below $2,000 \text{ m}^3 \text{ s}^{-1}$ (Walder and O'Connor 1997). The flow rate, however, after breaching a dam near Khadniyar would have been moderated by the hydraulic conditions in the Jhelum valley above the dam, that we assume were similar to those that exist at present. Assuming a steady discharge

The destruction of the temporary but “wonderful” stone dam (verses 91 and 93) could have been triggered by the removal of a few key parts of the edifice, which would then have collapsed the entire structure. The resulting gush of water through the deepened spillway was presumably sufficient to cause catastrophic erosion of the landslide, and to incise the river back close to its former channel level. We envisage that it may have taken 2–6 months to drain the entire Kashmir Valley.

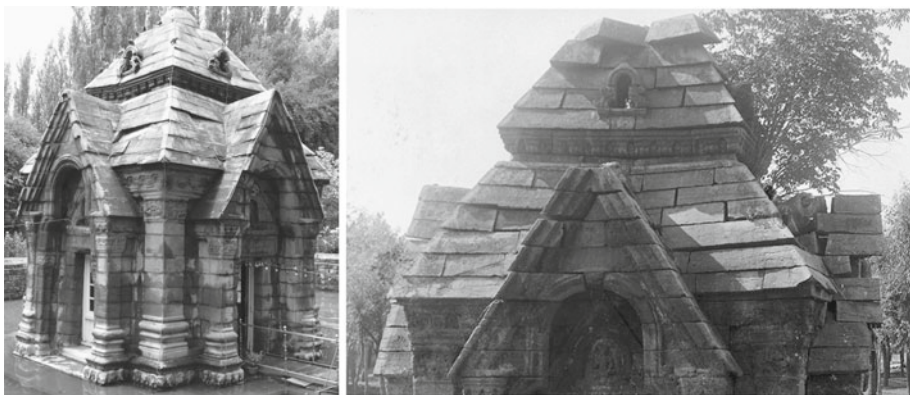
Fig. 7 The Pandrethan temple in 2006 (repaired in the twentieth century), with a close-up of the roof taken in 1903 after the 1885 earthquake. An earlier photograph in 1868 shows an identical misalignment of roof blocks ([Bilham et al. 2010](#)) indicating that earthquakes before 1885 were responsible for the observed displacements

Damage to the Pandrethan temple near Srinagar has occurred by lateral translation and shedding of blocks from the roof as the result of jostling of the entire structure (Fig. 7). The lower courses of the structure are not misaligned but the structure has lost its capstone. Since the ornate internal roof decoration appears to be undamaged, and damage to lower courses is largely absent, total collapse and subsequent reconstruction does not appear to have occurred (Bilham et al. 2010).

by up to 3.6 m of river sediments since their construction. This slow tilt down to the NW has raised the water table at the temple sites on the NE side of the valley (e.g. Pandrethan, Fig. 7), which is responsible for the now discredited inference by Cunningham (1848) that flooded temple compounds owe their origin to the worship of Naga. This was refuted by Marshall (1907) who noted that a flooded courtyard was incompatible with the provision of large stone tanks in the courtyard to hold water for temple ablutions. It is possible that some of the many temples mentioned in the Rajatarangini whose locations have now been lost, may in the future be discovered beneath sediments accumulated in the past millennium, and that the methods we outline here can be applied to their excavation.

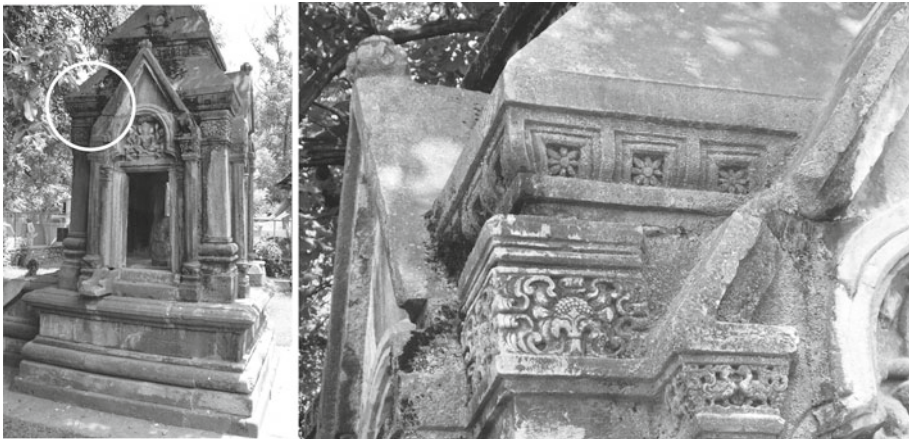
Fig. 8 Earthquake damage to the Payar temple has occurred through lateral displacement of the monolithic roof capstone. At some time in the past nine centuries the roof capstone has shifted ≈ 7 cm northward, with no damage to the underlying dressed stone blocks. We attribute the drift of the roof monolith to shaking during earthquakes. A close-up of the offset NW corner of the shifted roof stone is shown right, which, in our opinion, Kak (1933) erroneously diagnoses as a failed attempt to dismantle the temple

The temple is specifically of interest because it is the only temple that Kak (1933) specifically identifies as having been vandalized since its construction. He notes its roof is offset by some 3 cm (Fig. 8), as the result of a “feeble attempt to dismantle” the structure, apparently unaware that lateral block drift, often accompanied by rotation, is a characteristic feature of shaking in an earthquake. A small lateral offset has also occurred in one of the foundation blocks.

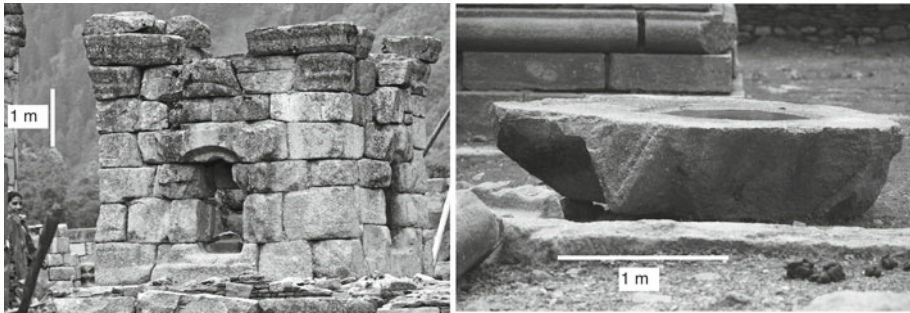
Fig. 9 The upper temple at Naranag and part of its granite roof lies inverted nearby. The monolithic roof measures $2.5 \times 2.5 \times 0.7 \text{ m}^3$. Note the absence of a masonry arch, and the assembly of walls from blocks of various dimensions

The upper and lower Naranag temples have each shed their monolithic stone roofs. In 2011 the temples were currently being repaired, and there is ample evidence from misplaced ornamentation on those structures currently standing, that the temples have been partly reassembled in earlier times. Although the wall blocks weigh less than several hundred kg the roofs are much more unwieldy, and the engineering skill to replace the massive roof monoliths has apparently been unavailable during these earlier repairs. The temples are assembled from locally hewn granite blocks (Fig. 9).

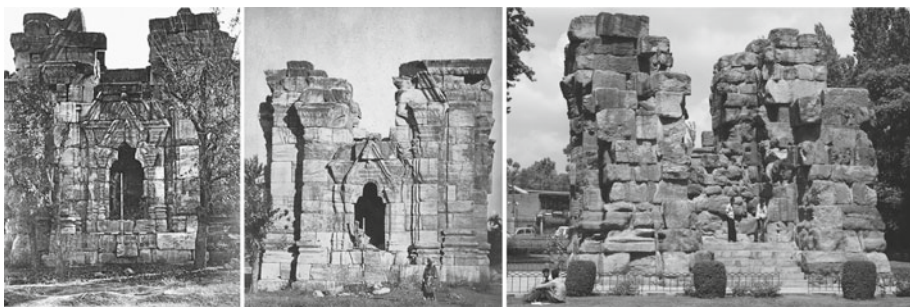
Fig. 10 Views of Sankaragaurisvara taken in 1868 from north and west compared to a 2005 photo from the west. The center view shows a lateral shift in the center trefoil keystone caused by an earthquake prior to 1868, before its complete loss in the 1885 earthquake (Fig 11). Note the lateral drift of blocks in the left hand corner. Significant corrosion of the limestone blocks has evidently occurred between 1885 and 2005

Comparing the pre-earthquake 1868 temple with the post-earthquake 1885 photos (Fig. 10) the damage to Sankaragaurisvara shows the collapse of the central trefoil portal, and the loss of blocks from the highest parts of the corners of the building.

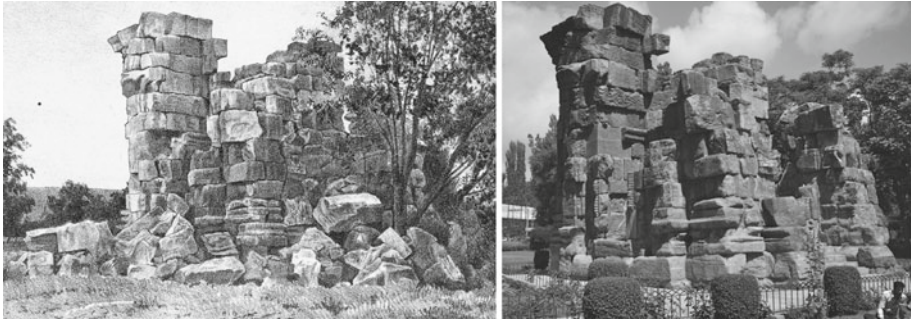
Fig. 11 (Left) Lithograph reproduced from Jones (1885) showing the immediate aftermath of the 1885 earthquake compared to a 2005 photograph from the same angle. (compare with previous Figure). It is possible that Jones took other photos but none were discovered in a search in the Calcutta photographic archives of the Geological Survey of India

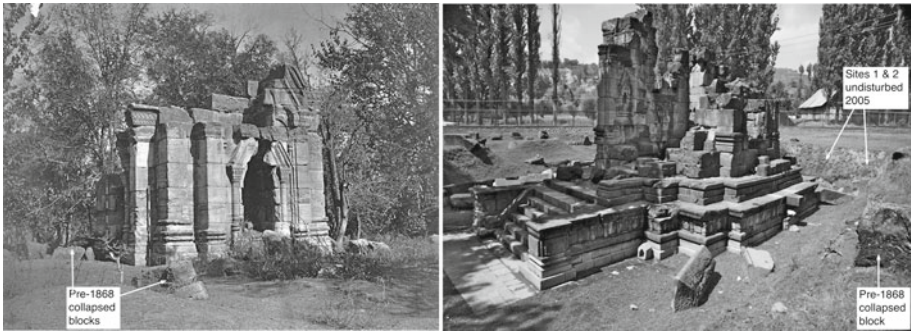
Fig. 12 (Left) View of Sugandhesa by John Burke in 1868 (Cole 1869). Blocks surrounding the temple visible in the foreground lie well above the foundation level and some to the north remain undisturbed in the 2005 photo (right), in contrast to blocks to the east, south and west which have been moved by archaeologists

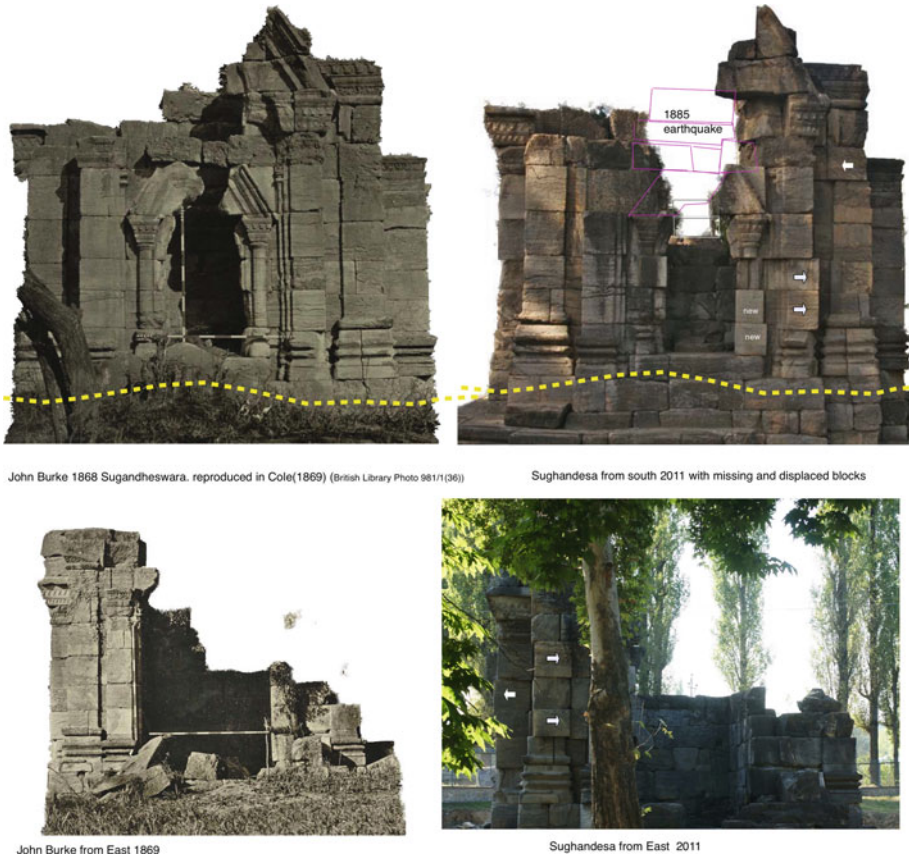
John Burke 1868 Sugandheswara. reproduced in Cole(1869) (British Library Photo 981/1/36)

Sugandhesa from south 2011 with missing and displaced blocks

Fig. 13 Views of Sugandhesa: top pair from the south in 1868 (Cole 1869, left) and 2011 (right), and lower pair from the east, showing damage sustained in the 1885 earthquake, and evidence of toppled blocks that we interpret to have fallen in previous earthquakes. Arrows highlight lateral block motions typical of earthquake jostling. The gradation of the poles visible in the left hand figures are in feet

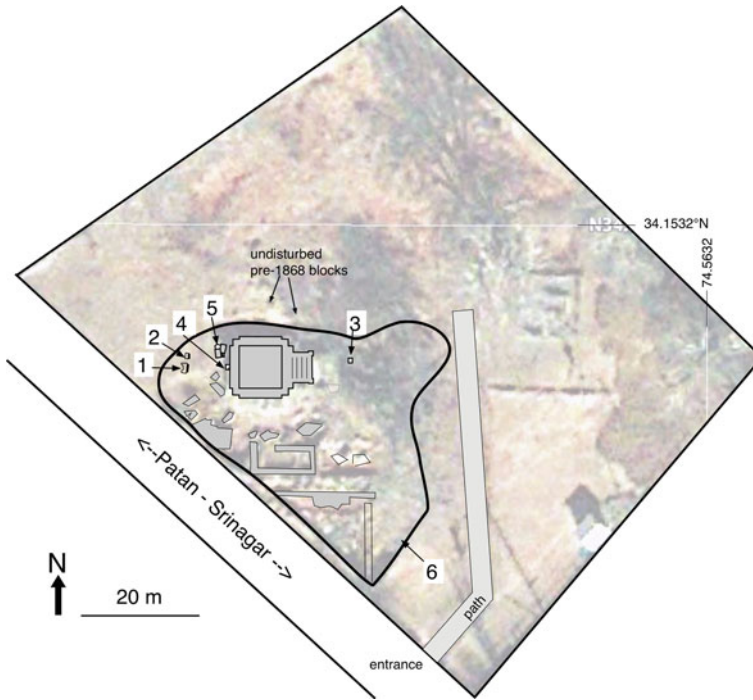
Fig. 14 Map of the Sugandhesa site from a Google Earth image showing the locations of six test pits. The region east and immediately south of the temple was significantly disturbed by Sahni (1918) and the region to the south cleared thoroughly by the ASI in 2010. Perhaps half of the temple complex extends beneath the Baramula/Patan/Srinagar Road. Site numbers correspond to those in text and Fig. 15. Figure 12 shows undisturbed blocks near the surface and the absence of any excavations at Sites 1 and 2 in 2005

the ASI, we undertook a number of minor excavations at the Sugandhesa site in a search for dateable materials. Our excavations were limited to six pits, one of which proved fruitless when we recognized from the exposed strata that they had been disturbed in the past century, or more recently, by archaeologists, and one where we learned little concerning the construction time of the temple. Prior to nineteenth century excavation the site was mantled by a layered deposit of Kerewa silts and clays that had attained a local thickness of 2.7 m. The regular layering of these deposits permitted us to recognize those regions of the site that not been disturbed by archaeologists. The most informative excavations concerning construction and destruction respectively were pits 4 and 5 located within 2 m of the western edge of the temple (Fig. 14).

In what appears to be rubbish pit near Site 6 (Fig. 14) we retrieved a 0.5 kg sample of spongy iron ore (pp. 50–53 [Stansbie 1908](#)) with the following principle components (Fe 59 %, Ca 6.6 %, Si 6.3 %, K 1.7 %, Al 1.1 %, Mg 0.7 %). We assume that this material may have been destined for fabricating the clamps used in temple construction, although as noted above, the mortise locations on the west face of Sugandhesa facing outwards (Fig. 15) suggests that this stone was reworked from elsewhere. Though now clean, [Kak \(1933\)](#) mentions that traces of rust were evident in these joints when he visited the temple in the 1930s.

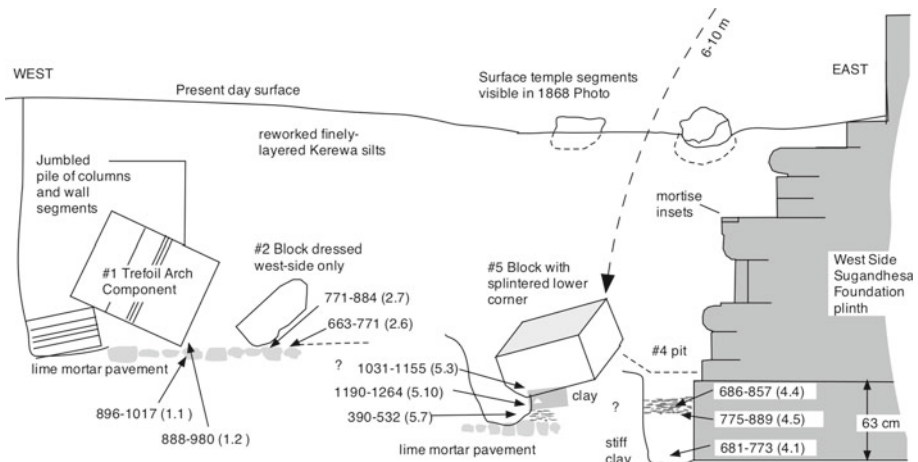
Fig. 15 Schematic section through excavations at west end of the Sugandhesa Temple with CE dates. A construction layer contiguous with the foundation confirms that temple construction was initiated before 890 AD. Less than 70 cm west of the temple a splintered block (with its spalled fragment nearby) collapsed on an ancient rubble layer and was flooded by a fine clay layer dated at approximately c.1200 AD. It is possible that block 1 and 2 were awaiting assembly prior to abandonment of temple construction. Although both blocks were exhumed only after 2005 (see Fig. 12 right) we found them exposed by the ASI in 2010 with no dateable materials above them. Accelerator mass spectrometer date conversions are listed in Table 1

construction layer of chips at this site. Sample 1.2 (888–980 AD) was found in a soil/clay layer between the megablock and the stone floor and, sample 1.1 (896–1017 AD) from just below the pavement. Block 2 was a smaller block roughly one quarter the size of Block 1, but was dressed only on its upper west-tilted surface. Its lower surface appears to have been supported by another block at some time because fluvial sedimentary layers now underlie the block with a conformable graded bedding deposit, suggesting infilling of a void. Two detrital charcoal samples here (2.6 and 2.7) indicated dates of 663–771 and 771–884 AD.

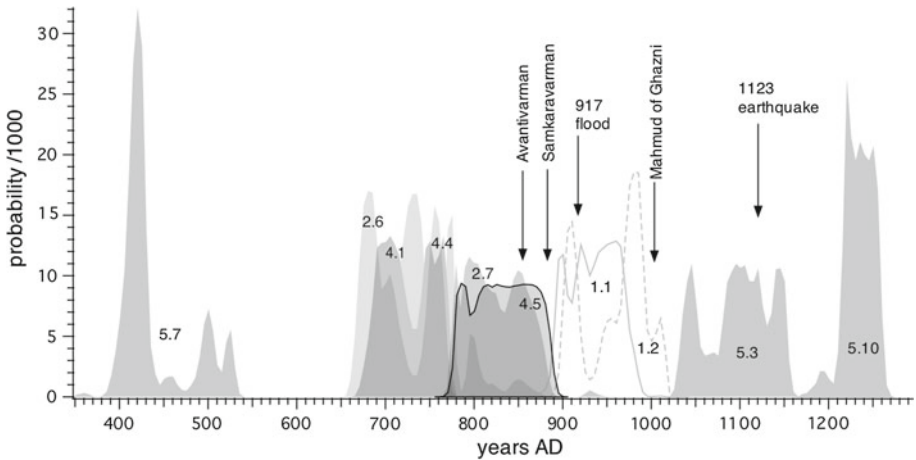
Fig. 16 Probability distributions from calendric date conversions of ten C14 samples from layers beneath temple blocks on the west side of Sugandhesa Temple (Table 1; Fig. 15). The central cluster of detrital C14 dates are consistent with a construction start for the temple corresponding to the reign of *Samkaravarman*, but the temple site may have been occupied 400 years earlier

The eleventh and thirteenth century probable date distributions in Fig. 16 (5.3 and 5.10) are confined to a clay that developed after the collapse of block 5 from the west face of the temple onto a surface of considerably older age. A possible earthquake is mentioned briefly by *Kalhana* but is not mentioned in other histories, which could be responsible for this damage. “1123 AD: The orb of the day blazed fiercely, the earth trembled frequently and disastrous cyclones blew which brought down trees and boulders” (Book 8, Verse 1167; [Stein 1898](#)). These later dates do not correspond to known periods of willful desecration. For example, it is believed that *Mahmud of Ghazni* was repulsed outside the valley and prevented from invading the Kashmir Valley 1015–1021, and Muslim rule slowly developed only after

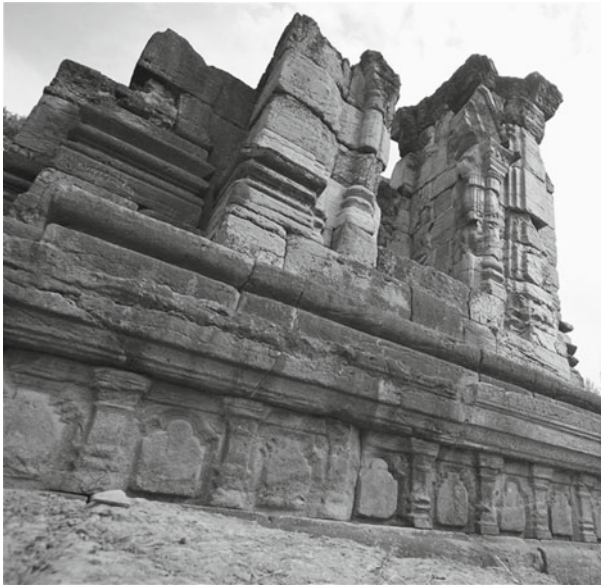
Fig. 17 View from Block 5 (lower foreground) upwards showing west face of the Sugandhesa ruin (much foreshortened by the wide angle lens used in this view). The height of the pillar right is ≈ 8 m, and block 5 is believed to have been thrown 0.7 m clear of the ruin from the central pillar, without impacting the lower structure. Note lateral displacement of upper blocks within the columns caused by shaking, and unfinished decoration in the frieze surrounding the basal pedestal. The top surface of this pedestal includes depressions mortised for iron clamps which [Kak \(1933\)](#) noted contained traces of rust. We exposed an iron ingot from Site 6 similar to others that may have been destined to fasten parts of the Sugandhesa ruin now hidden from sight

The collapse of Block 5 and others from the west side of the temple has occurred without significant damage to the temple plinth (Fig. 17). These were heavy stones that fell from a considerable height (>7 m), and had they impacted the structure during their descent there is little doubt they would have splintered the cornice or other layers. In principle this permits estimates of their minimum initial velocities.
