The Geological Society of America  
 Special Paper 471  
 2010

## *Historical earthquakes in Srinagar, Kashmir: Clues from the Shiva Temple at Pandrethan*

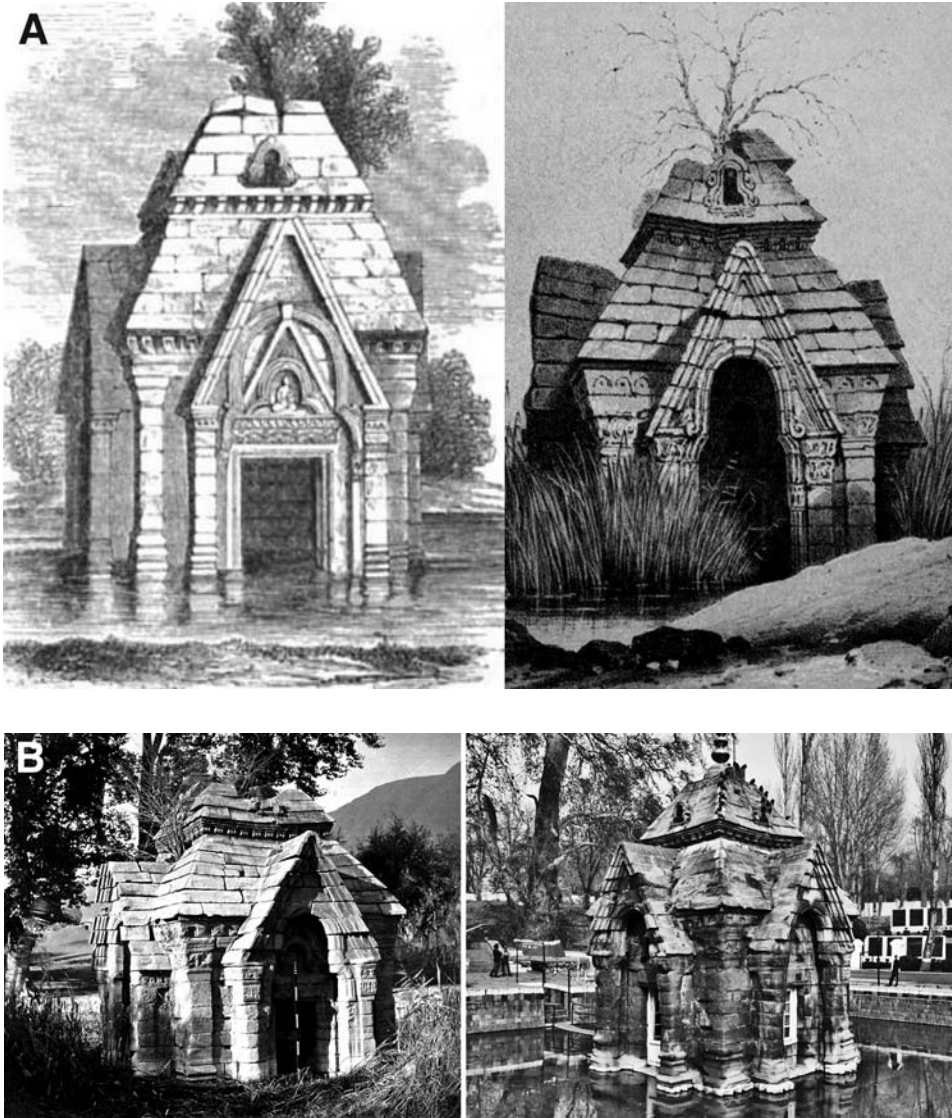
Figure 3. (A) Our earliest glimpse of Pandrethan (left) may be a sketch published by Cunningham (1848), here reproduced by Fergusson (1867), which shows a tree with abundant foliage sprouting from the roof. In the 18 July 1860 painting of Pandrethan from the north (Knight, 1863, p. 354), the internal tree is devoid of leaves (right). “The building which alone remained in at all a perfect state was situated in a sort of pond or tank of slimy green and was quite inaccessible without a boat.” He complains of mosquitoes plaguing his sketching and ants eating his paints. (B) Left: John Burke’s 1868 photo of the Pandrethan temple from the south, compared to approximately the same view in December 2008. The three upper roof courses were missing on the SE side in 1868, but are present, though dislodged on the NW side (Fig. 4). Note scale with 1 ft gradations in doorway on left.

In 1868, the Pandrethan temple was photographed from the south by John Burke (Fig. 3) and is one of three views published by Cole (1869), who writes:

The early sketches, the 1868 photograph, and two others reproduced by Cole (1869) show many of the same roof blocks in the temple displaced from their original positions. The tree that grew from, or through the roof in 1887, was evidently growing in 1848 and in 1860. The similarity between the 1868 and 1887 views suggest that shaking in 1885 was insufficient to cause further damage to this masonry structure, and hence that

One is left to consider the damage to the temple that is evident in the 1868 photograph. The damage to the roof as well as the displaced blocks lower in the structure are, we conclude, more consistent with earthquake damage than vandalism or natural weathering. In particular, close inspection of the roof shows consistent offsets of the six lower courses of roofing blocks, no offset of the decorated overhang and sequentially increasing offsets of the five uppermost courses (Fig. 4), suggestive of oscillatory jostling. The uppermost blocks are perched precariously. Vandals, had they removed the missing pyramid, would surely have toppled this penultimate layer (Fig. 5).

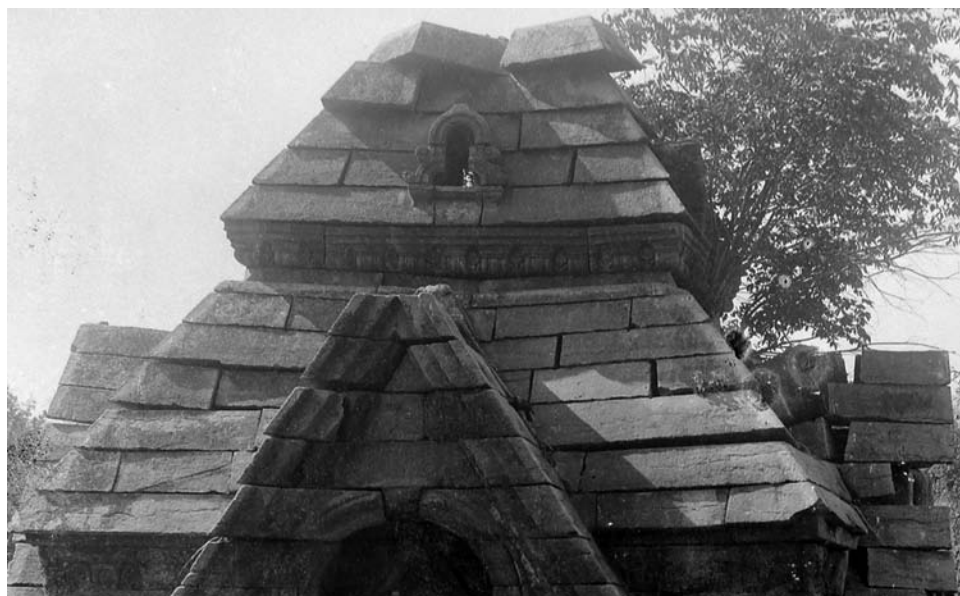
Figure 4. Close-up of Oldham's 1887 view of the temple from the NW. Note the parted SW gable (lower right) with its missing third block, also missing in Burke's 1868 photo and Kak's 1933 sketch. Note the irregular offsets to the SW of the six lower blocks, and sequentially increasing offset of the five upper blocks. The summit pyramid has been lost, and is now replaced by a modern dome with a triple-orbed pinnacle.

The lower thirds of Oldham’s 1887 glass half-plate negatives have been damaged by water, and it was necessary to reassemble the broken halves of his NW view digitally. The date of the photo is recorded as August 1887 in the Calcutta photographic archive of the Geological Survey of India, and Oldham’s visit is recorded by Tom LaTouche in a letter from Srinagar to his mother dated 12 August 1887 (Bilham, 2008).

In a hand-written note on the 1887 protective envelope that contained his half-plate glass negative, R.D. Oldham states “Temple at Pandrethan, Srinagar, showing stones displaced by earthquakes.” Writing this 2 yr after the 30 May 1885 Kashmir valley earthquake, his use of the plural indicates that he does not ascribe damage to any single earthquake. He was, moreover, in the Andaman Islands at the time that the 1885 earthquake occurred. From earlier photographs, it is clear that the disposition of the uppermost blocks is identical before and after the May 1885 earthquake. The 1885 earthquake resulted in estimated EMS intensity VI shaking to the east and west of Pandrethan. We conclude that that the damage to the temple was the result of one or more earthquakes prior to 1868. Since the temple was unaltered by estimated intensity VII shaking in 2005, we deduce that the causal earthquake that shifted the summit blocks was caused by shaking with intensity VIII or IX.

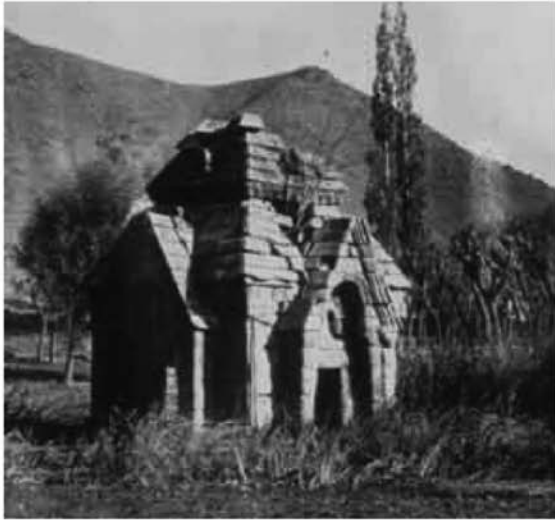
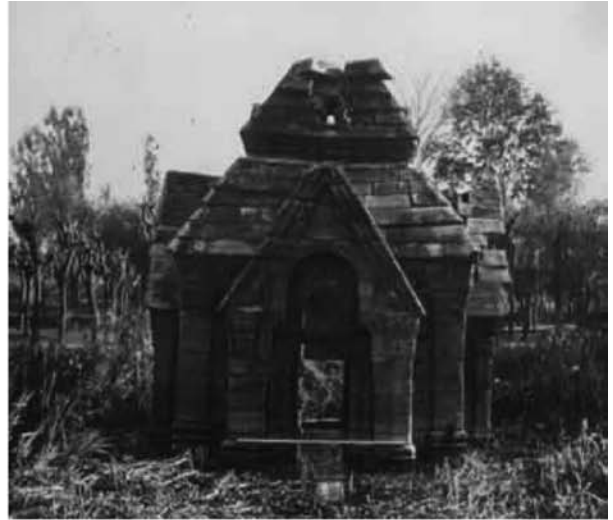
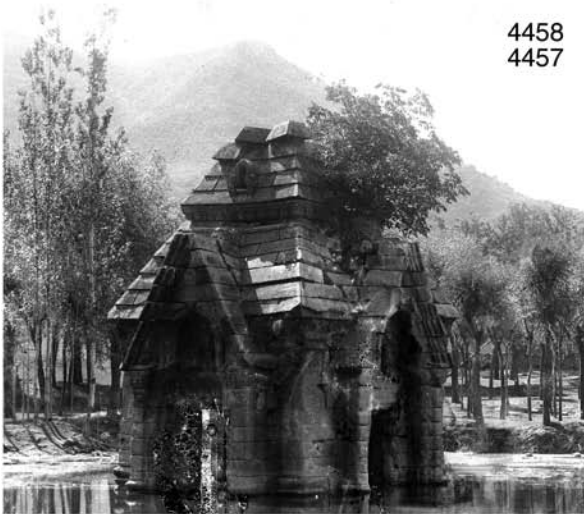
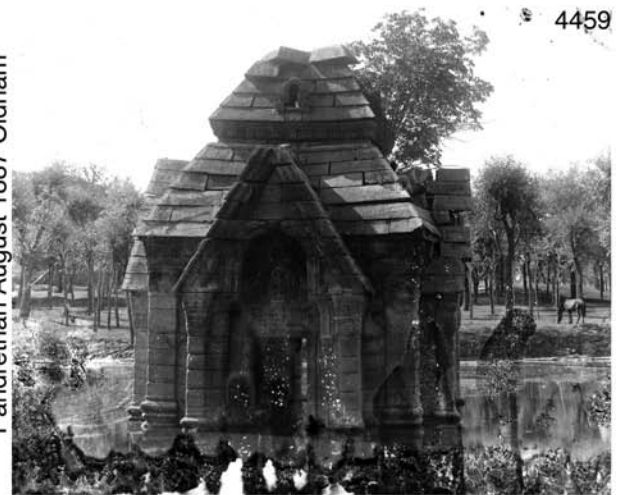
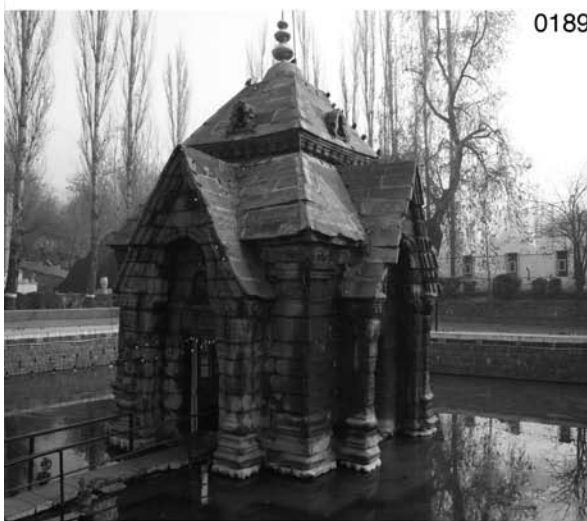
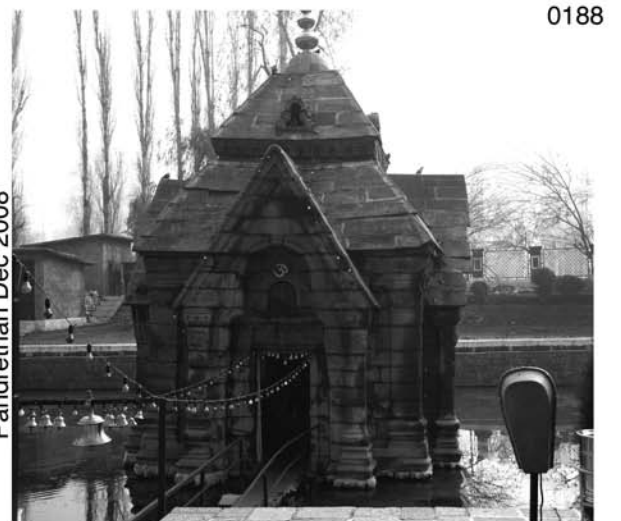
Figure 5. Pandrethan Temple now, and before and after the 1885 earthquake (Cole, 1869; Oldham, 1887). Left-hand panels are viewed from NW and right-hand panels from NNW (see Fig. 6). Roof vegetation was recorded in a photograph by Marion Doughty (1902).

Several stone blocks in the roof remain misaligned. These, and those that were repositioned in recent repairs, testify to the building being shaken to the extent that many blocks were moving differentially during a former earthquake. The displaced blocks are found at high levels (in the roof) and not at lower levels near the pediment.
