Assessment of the long-term seismicity of Athens from two classical columns

Nicholas Ambraseys¹ and Ioannis N. Psycharis²

Abstract

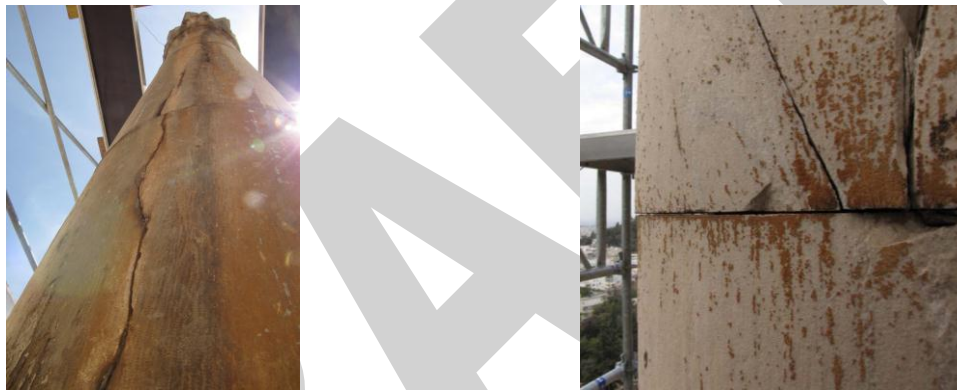
Figure 6. Typical damage to the shaft of column W caused by the oxidation and expansion of its dowels (**Zambas *et al.* 2011**).

Concerning the column's shaft, which consists of 5 drums, the damage that can be seen to the stone of the drums (**Figure 6**) is due to the initiation of cracking by the swelling and oxidation of the dowels. There is also a small dislocation of two adjacent drums and two slight scars where the stone has peeled off by grazing cannon balls during the sieges of the Acropolis. In all, the column has been hit by small cannon balls in four places, which caused very little damage. Higher up, the lower corner of the 5th drum facing southeast shows a diagonal fracture and a vertical open crack which was caused by the swelling of the dowel.

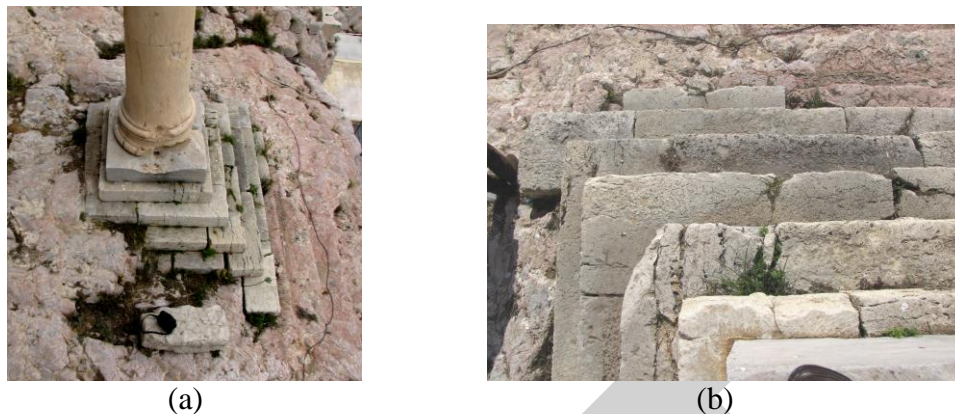
Figure 7. Column E: (a) Fragmented limestone stepped slabs of the pedestal; (b) View from above of the condition of the limestone stepped slabs of pedestal E (facing south).

The general impression of the pedestal of column E and to a lesser degree of column W is that the limestone slabs from which they are made are not as tightly placed together as originally, particularly the lower slabs (**Figure 7**). The two bottom slabs are slightly inclined to the south, and one of them is broken. Between them here are also a few open and displaced vertical and horizontal joints, probably caused by the growth of roots of cacti, by erosion from rainwater draining down through the Wall at the back and down the surface of the ledge and possibly from ground vibrations caused by mine explosions during the siege of 1826. **Figure**

7 shows the degree of fragmentation of the limestone stepped slabs of the front part of pedestal E after the removal of vegetation.

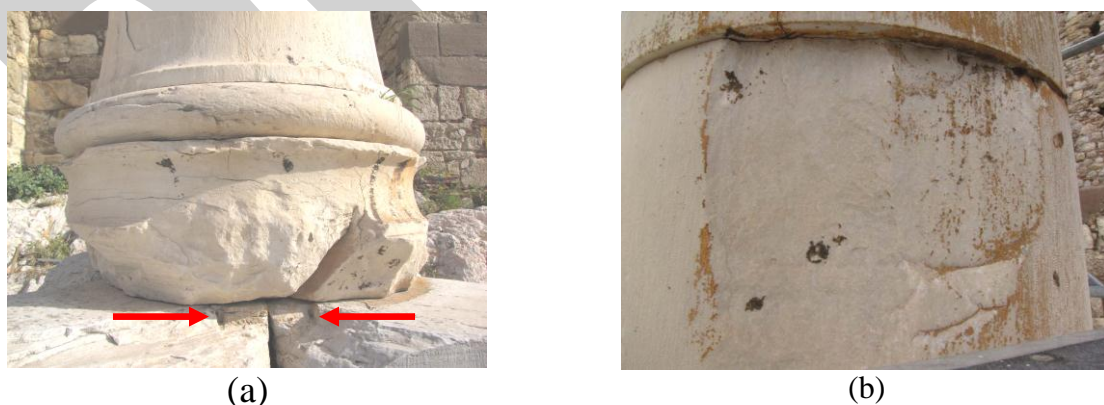
Figure 8. Column E: (a) Missing double-T clamp originally connecting the two pieces of the plinth (its position is shown between the two arrows); (b) Flaking off of skin of the stone of the 2nd drum indicating rocking between 2nd and 3rd drums.

The base of the column has a normal profile with a full lower torus (**Figure 8a**). In an attempt to extract the iron dowels which held together the drum and the base, the northwest, south and southeast parts of the torus, scotia and parts of the plinth were cut back deliberately and a good part of the south part of the base was broken up stripping the base of a good part of its stone. Notice that this deliberate stripping and mutilation of the stone was done where the base of the column straddles the plinth at the contact point of the two underlying pieces of marble.

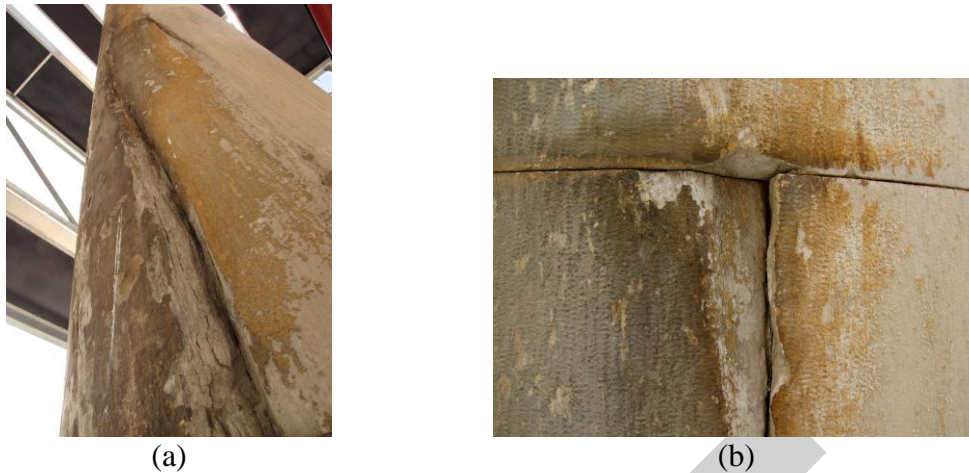
Figure 9. (a) Expansion of the stone and the formation of tension cracks due to oxidation of dowel(s) of the 5th drum. Staining action caused by corrosive metals, Rust-colored bleeding can only occur from stone that contains a high concentration of iron pyrite; (b) Detail showing damage to the stone due to swelling of oxidized dowels enhanced by temperature effects. The expansion of the skin of the drum is arrested by frictional forces at its contact with the drum below.

For more than 20 centuries these columns have suffered cracking of the stone due to the rusting and swelling of iron dowels and stone, from temperature effects, warfare, high winds and natural ageing of their pedestals (**Figures 4, 6, 7, 9**). In addition to which, both columns have been damaged by robbers who cut into the stone in an attempt to remove the metal dowels (**Figures 5c, 8a**), which seriously affect the integrity of the columns.

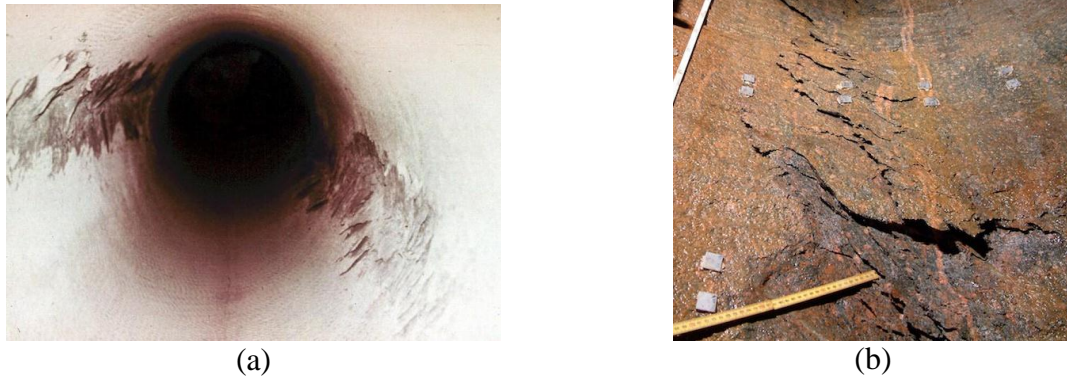
Figure 10. (a) Spalling of rock surface of tunnel wall with a tendency to shrink shortly after its formation; (b) Spalling of rock surface of bore hole (Courtesy Prof. D. Martin).

Figures 10 illustrate the inverse of the problem, that is the tensile spalling that we see on the inside of tunnels in massive brittle rock under high stresses. As Figures 11 show, for a wide range of uniaxial strengths in these rocks, initiation of brittle fracture starts at about 40% of the Uniaxial Compressive Strength (UCS). If conditions are right, brittle fracture can propagate to form a "notch" in the tunnel wall, shown in Figures 10b. These notches are a reflection of the attempt of the rock to find a shape that results in equilibrium between the brittle failure conditions and the in situ driving stresses.

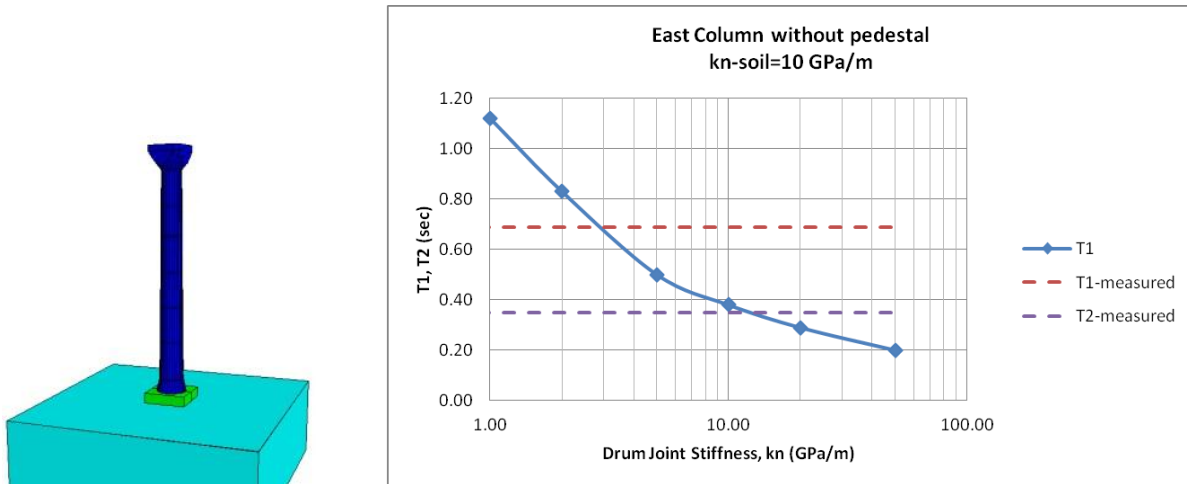
Figure 15. Variation of the calculated fundamental period of vibration of the East column without pedestal vs. the normal joint stiffness of the drums, k_n and comparison with the measured periods.

This investigation showed that the most appropriate values for the joints of the column are (**Figure 15**): $k_n = 10$ GPa/m and $k_s = 2$ GPa/m, for which the fundamental period of the column is equal to 0.34 sec and practically coincides with the measured period T_2 (equal to 0.35 sec). It is noted that when these values were applied to the full numerical models, including the pedestals, the fundamental periods of both columns matched well the measured periods T_2 .

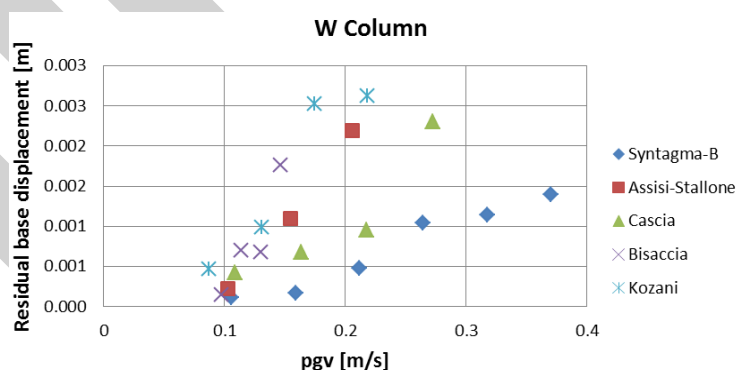
Figure 20. Permanent dislocation at the base of the W Column versus the *pgv* of the ground motion for the earthquakes considered.

In general, the maximum level of shaking may be assessed from a back analysis of the observed damage. As reported by Zambas *et al.* (2011), column W is displaced at its base by approximately 25 mm. This dislocation is considerably larger than the one predicted by the numerical model for single application of the ground motions considered. This is shown in **Figure 20**, in which the residual displacement at the base of column W for each earthquake is plotted versus the corresponding *pgv* of the excitation. It is seen that the considered ground motions produce dislocation of the column smaller than 3 mm in most cases, even if they are amplified significantly (but less than what is required to topple the column).

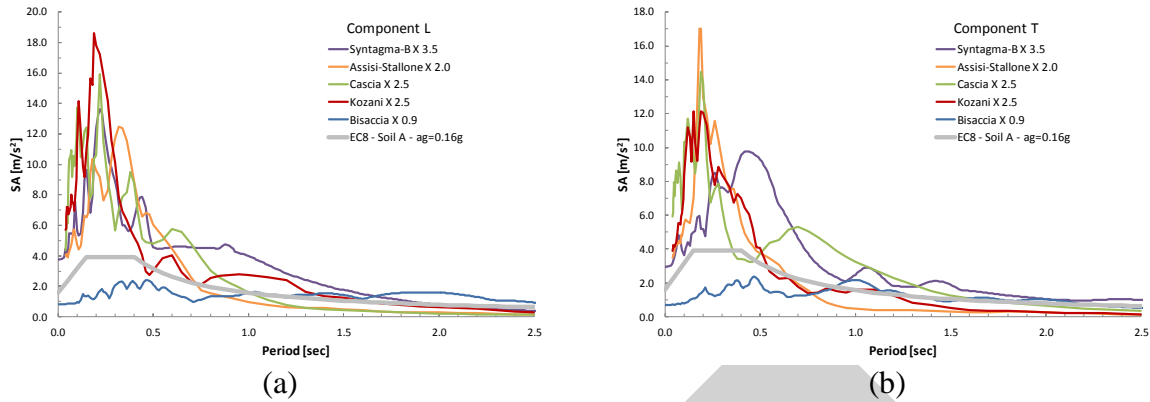
Figure 23. Acceleration response spectra for 5% damping of the earthquakes considered, amplified as in Table 4 compared with the EC 8 spectrum for the centre of Athens: (a) Component Long; (b) Component Trans.

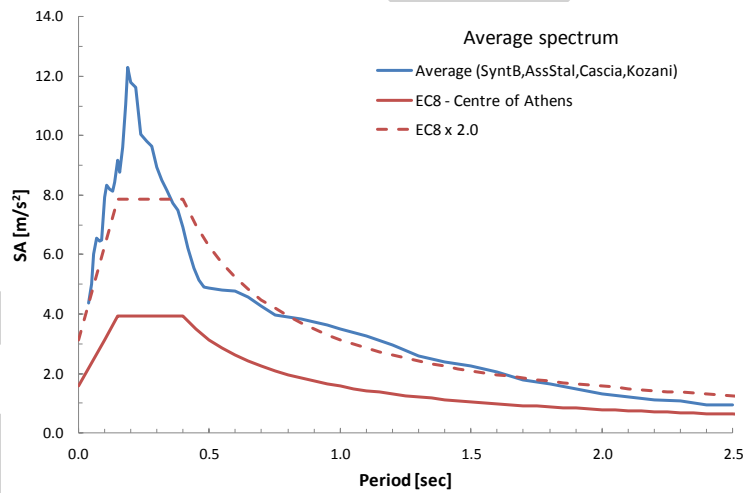
Figure 24. Average acceleration response spectrum for 5% damping of both horizontal components of four earthquakes considered, amplified as in Table 4 compared with the EC 8 spectrum for the centre of Athens.

corresponds to mean return period of the seismic action $T_R = 475$ years, while the average spectrum of the worst-case earthquakes shown in **Figure 24** corresponds to events that probably have not happened yet, i.e. to events of return period at least 2300 years.
