Kathmandu Valley Shaking Intensities Gorkha earthquake 25 April 2015

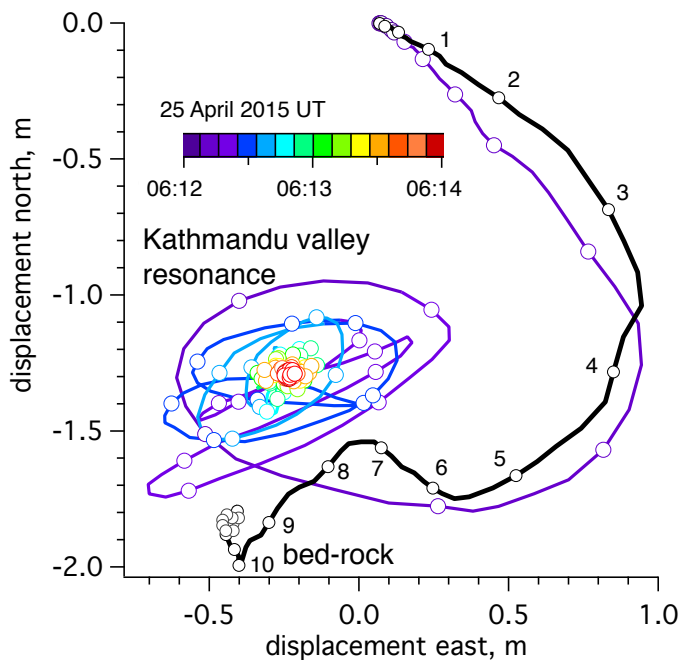
Two GPS receivers recorded the translation, upheaval & oscillation of the Kathmandu valley sediments each 0.2 s; KKN4 (black on rock) and NAST (colored time-code on sediments). In map view the displacements input to the valley describe a large sickle-shaped path that shifted the northern edge of the valley 2 m south in 10 seconds (numbers indicate 1 second intervals). Partly because the slip pulse beneath the valley propagates southward and partly due to a phase lag in the sediments the sediments respond a few seconds later. After the tenth second the sediments continue to

oscillate, initially with a 7 s forced frequency, and after two cycles with 5 s and 3.5 s resonant oscillations that continue for 2 minutes with amplitudes exceeding 1 cm. At the same time the valley rises by 1 m in the north and by a lesser amount in the south. The uplift is caused partly by translation southwards and upwards on a shallow ramp, and partly by elastic compression caused by the termination of rupture propagation near the southern edge of the valley.
